Major Mining Claims and Risk Control Failures

Le Roux van den Berg
Lloyd Warwick International

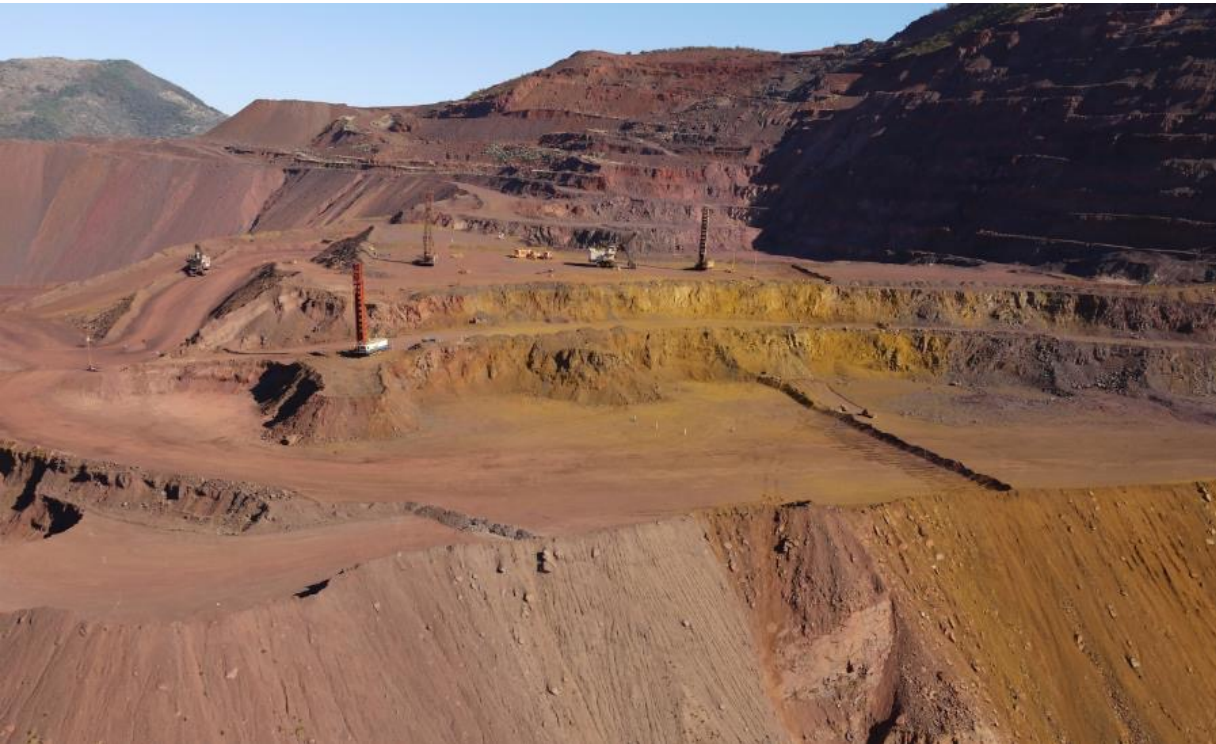
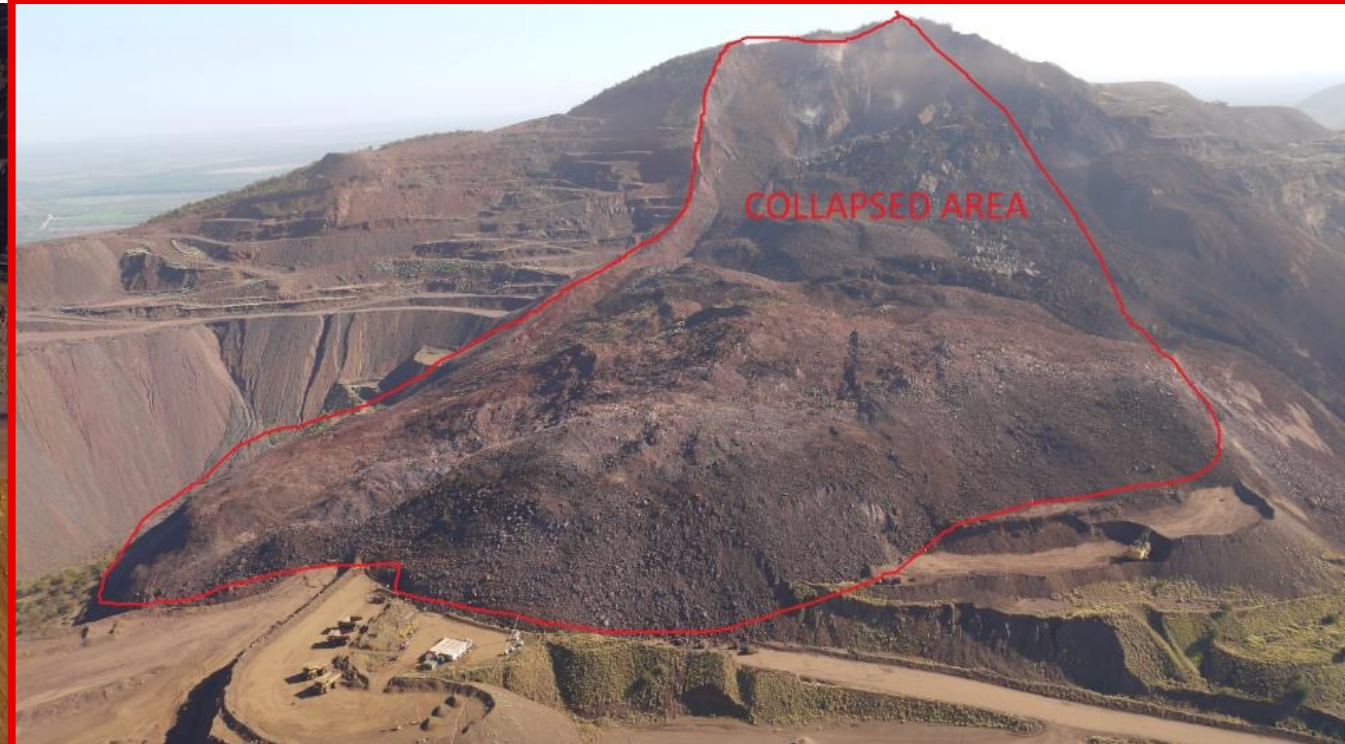
Pit Failure

- Control = Slope Angle @ Performance Standard
- Dependency = Mining Practice
- **Verification = Radar Monitor and Human Response**
- Control Quality = Human Behaviour

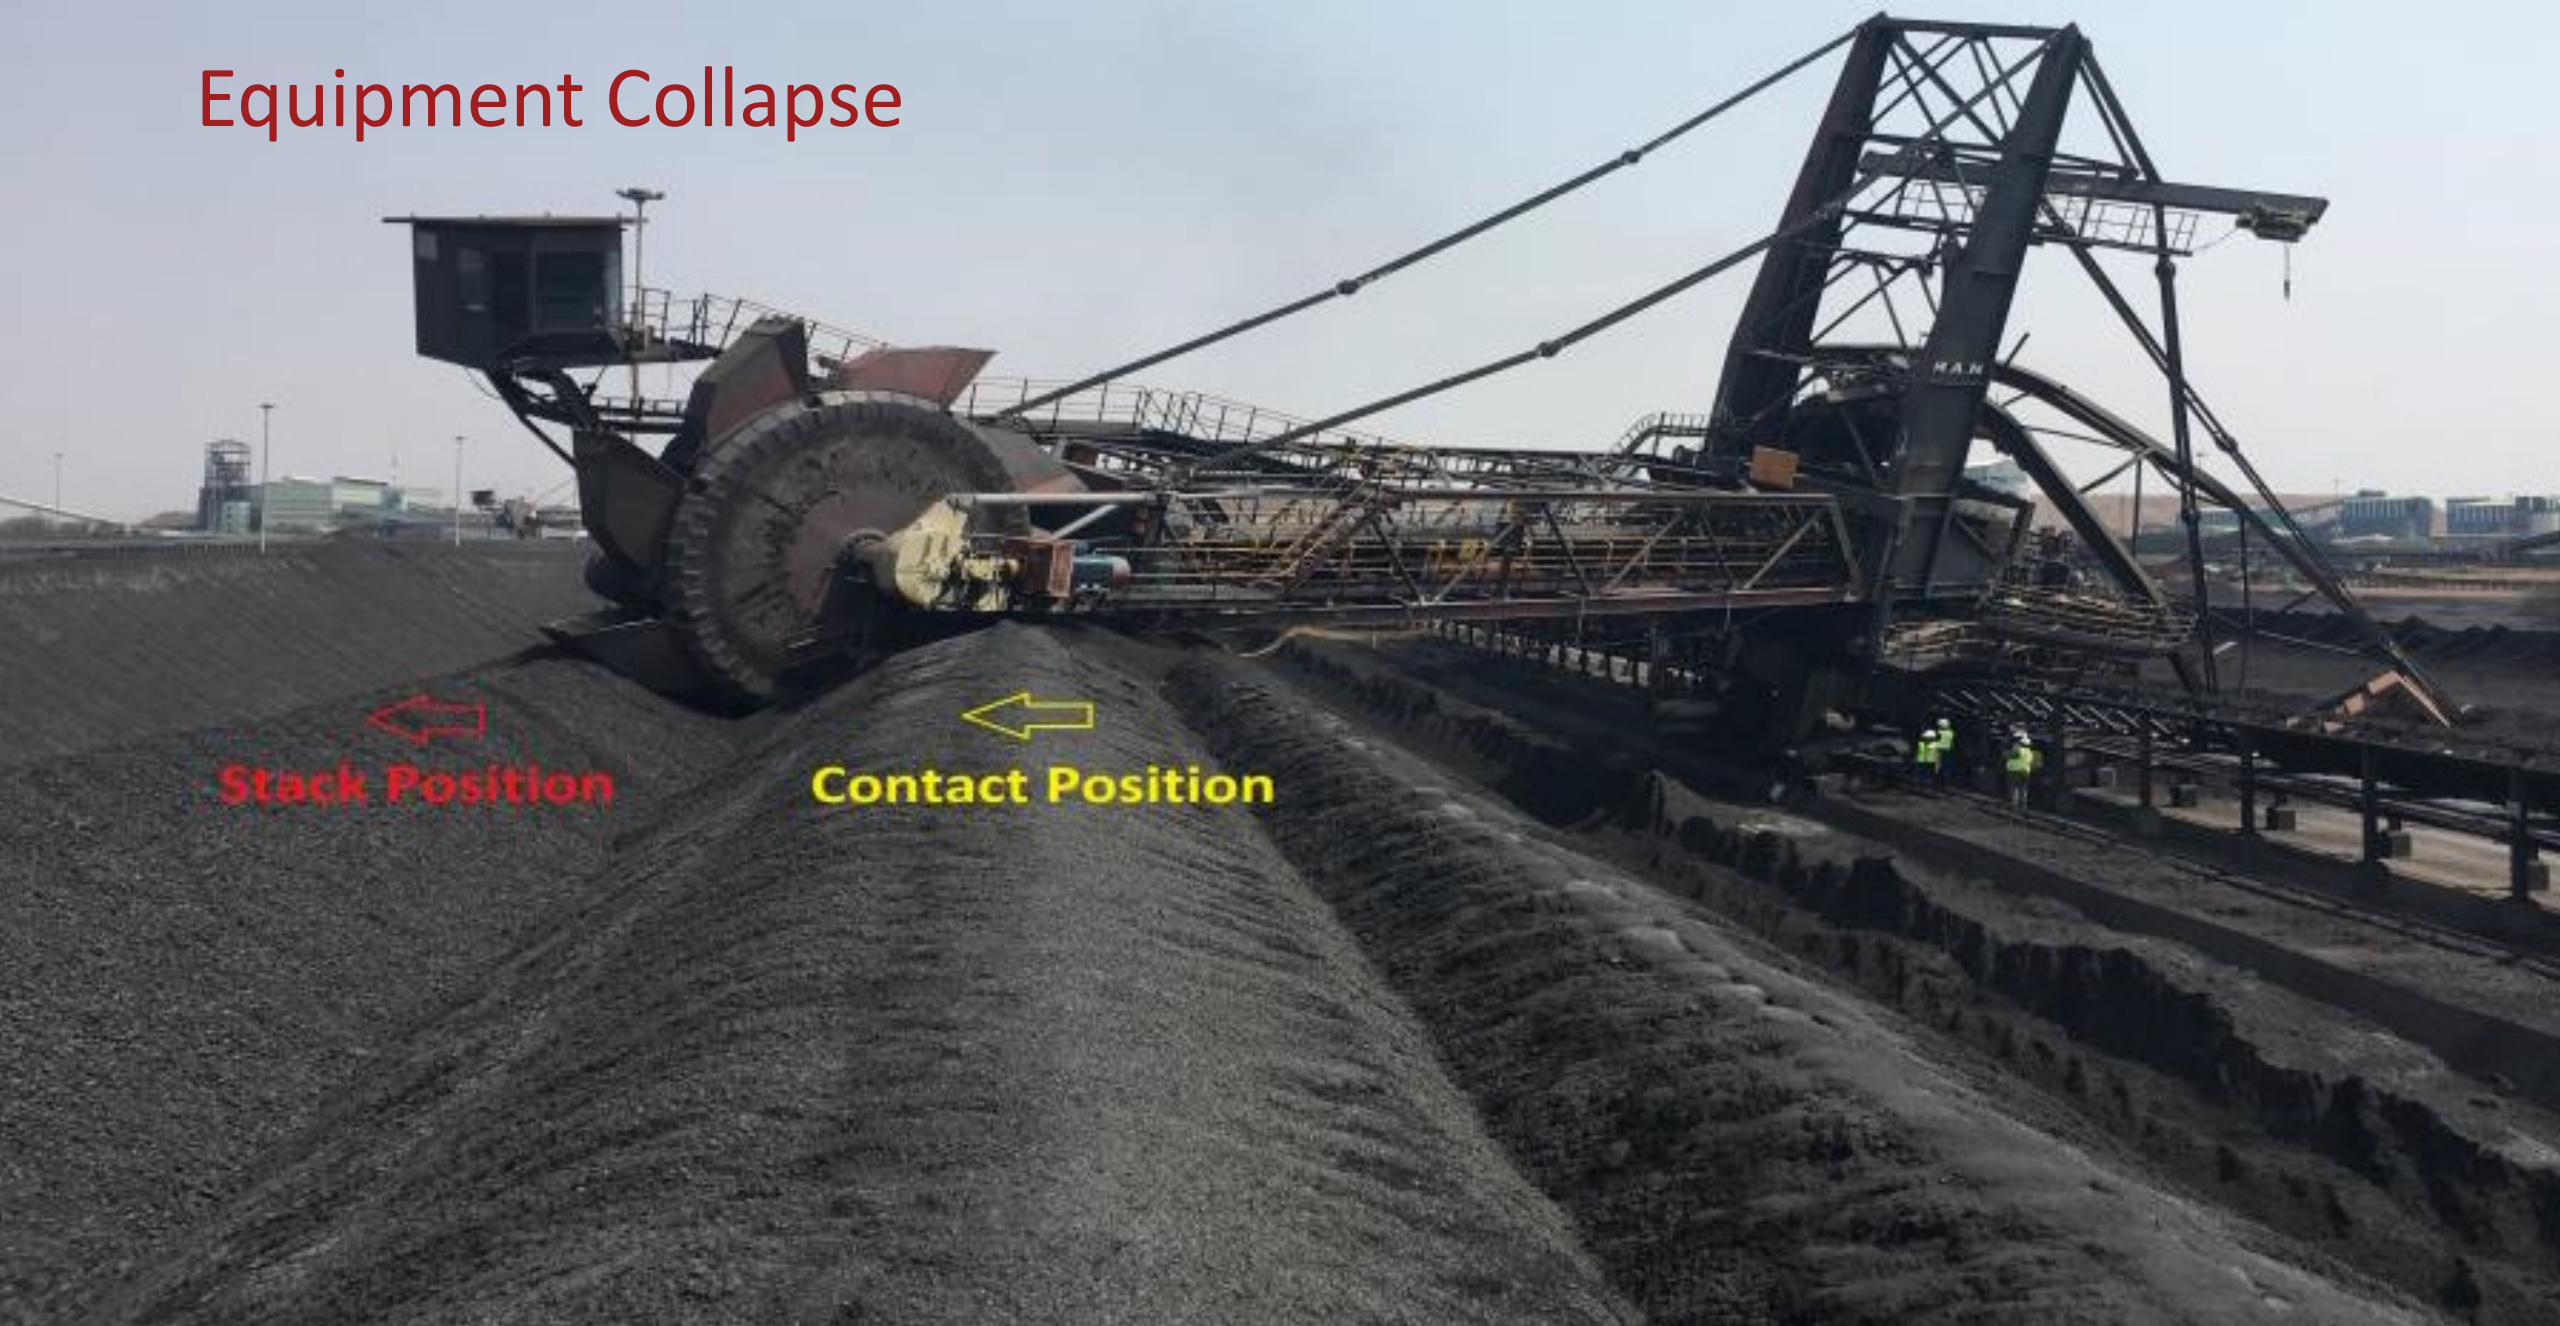
Equipment Collapse

Stack Position

Contact Position

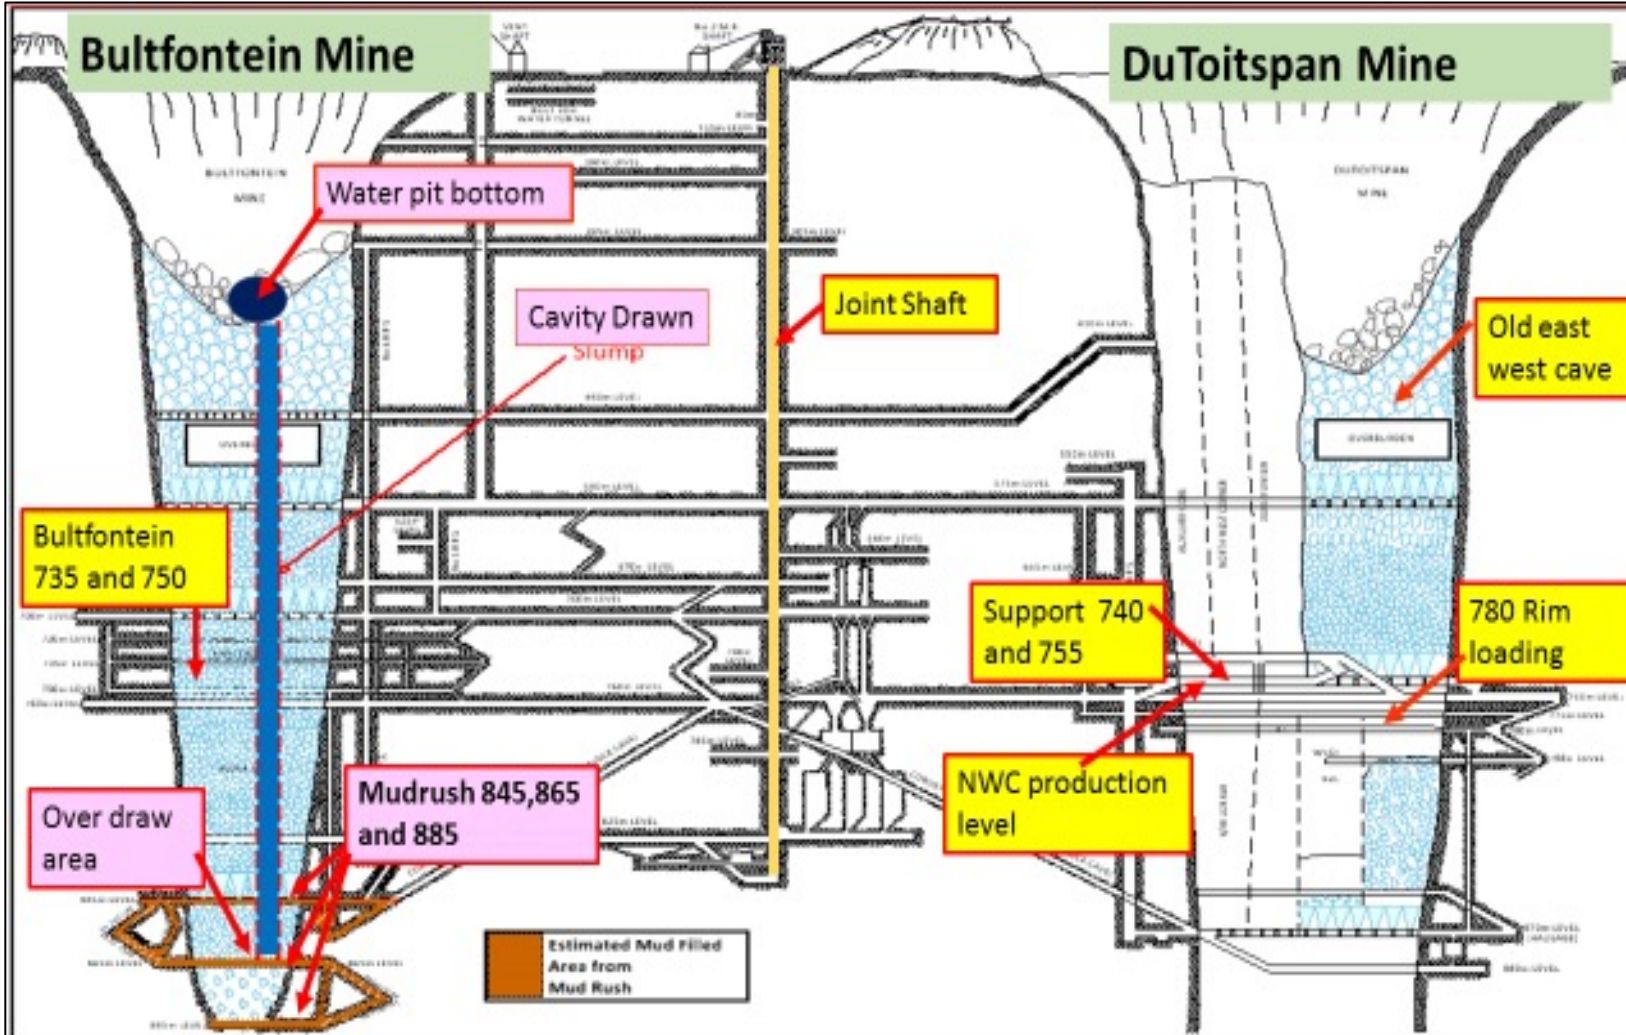
Mud Rush Requirements:

1. Fines
(mud forming material)
2. Water
(sufficient to wet fines)
3. Trigger
(disturbance to initiate movement)
4. Discharge Point
(to allow material to enter workings)

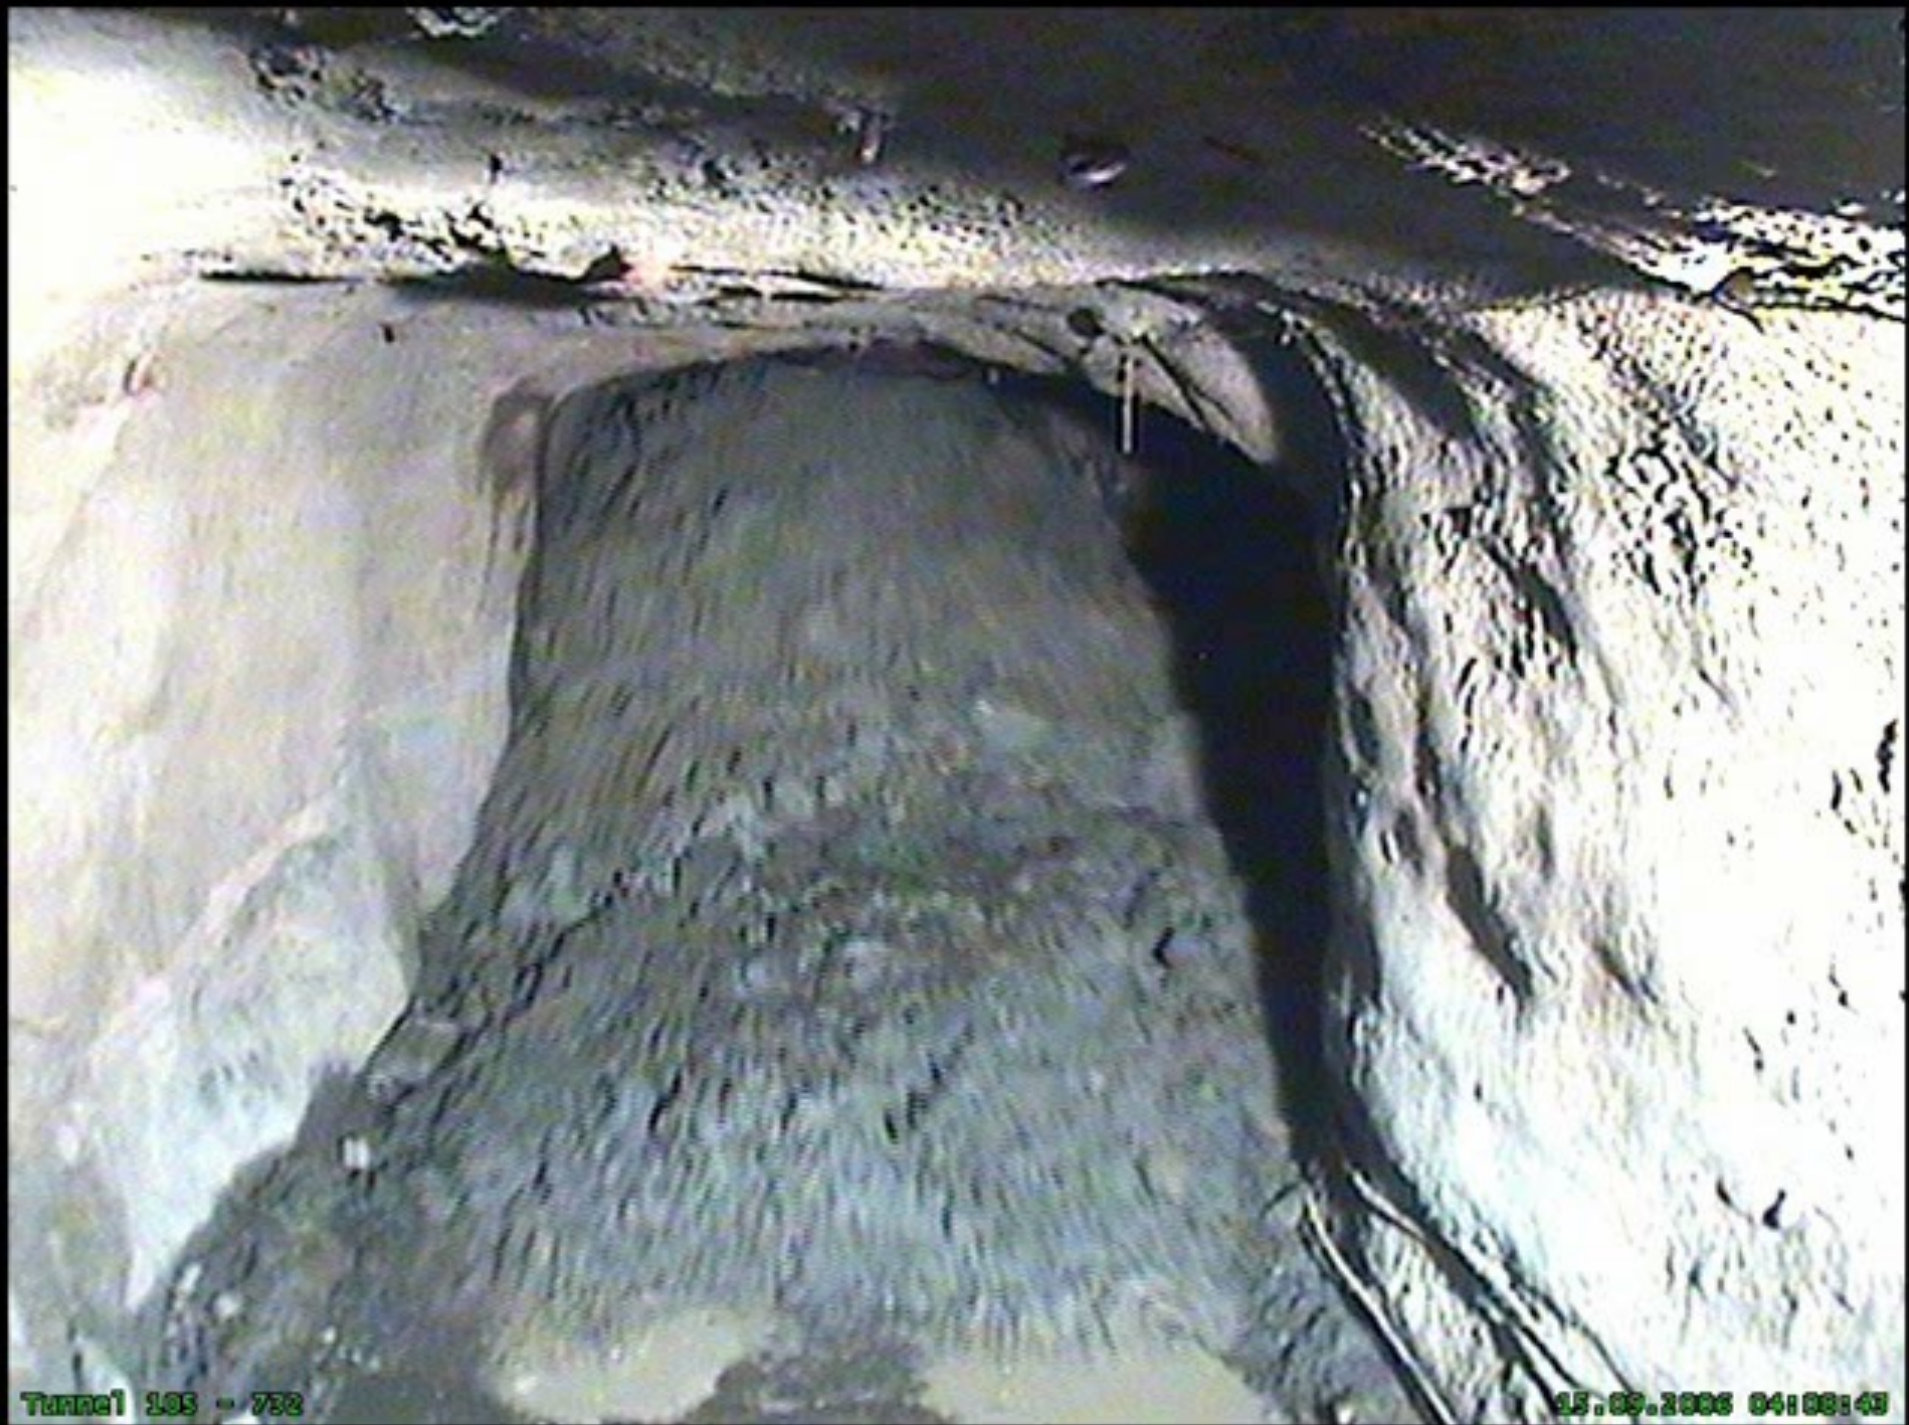
Tunnel 103 - 732

Mud Rush

- Control = Water level
- Dependency = Pumping
- **Verification = Water Balance**
- Control Quality = Human Behaviour

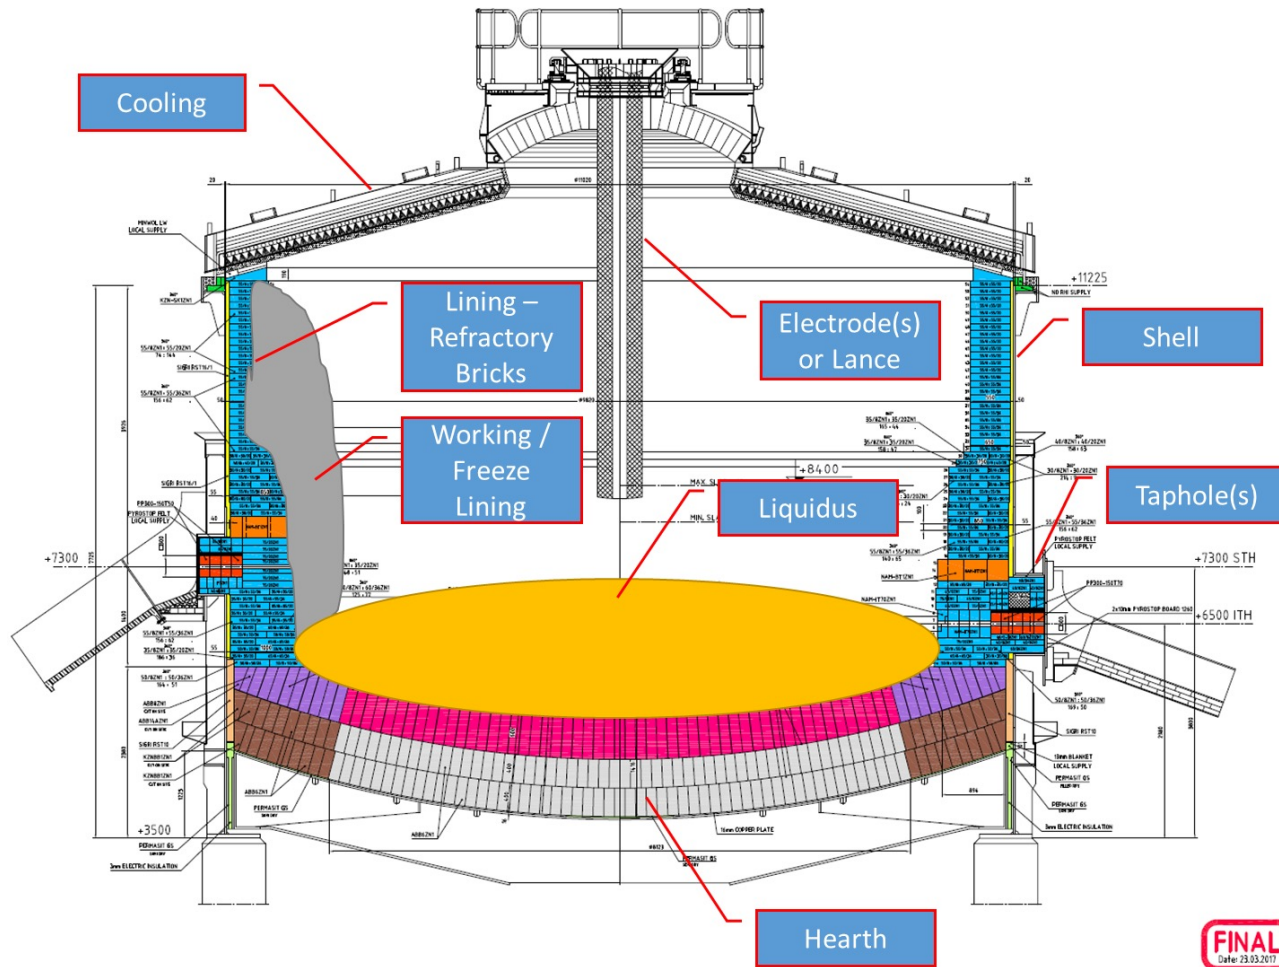
Furnace Losses

NOTE: DON'T CUT REFRACTORY BRICKS SMALLER THAN 10mm ON THE HOT FACE OF THE BRICKS & USE EXPANDED BRICKS IN THE TAP HOLE AREA. MET MUST BE USED IN THE TAP HOLE AREA.

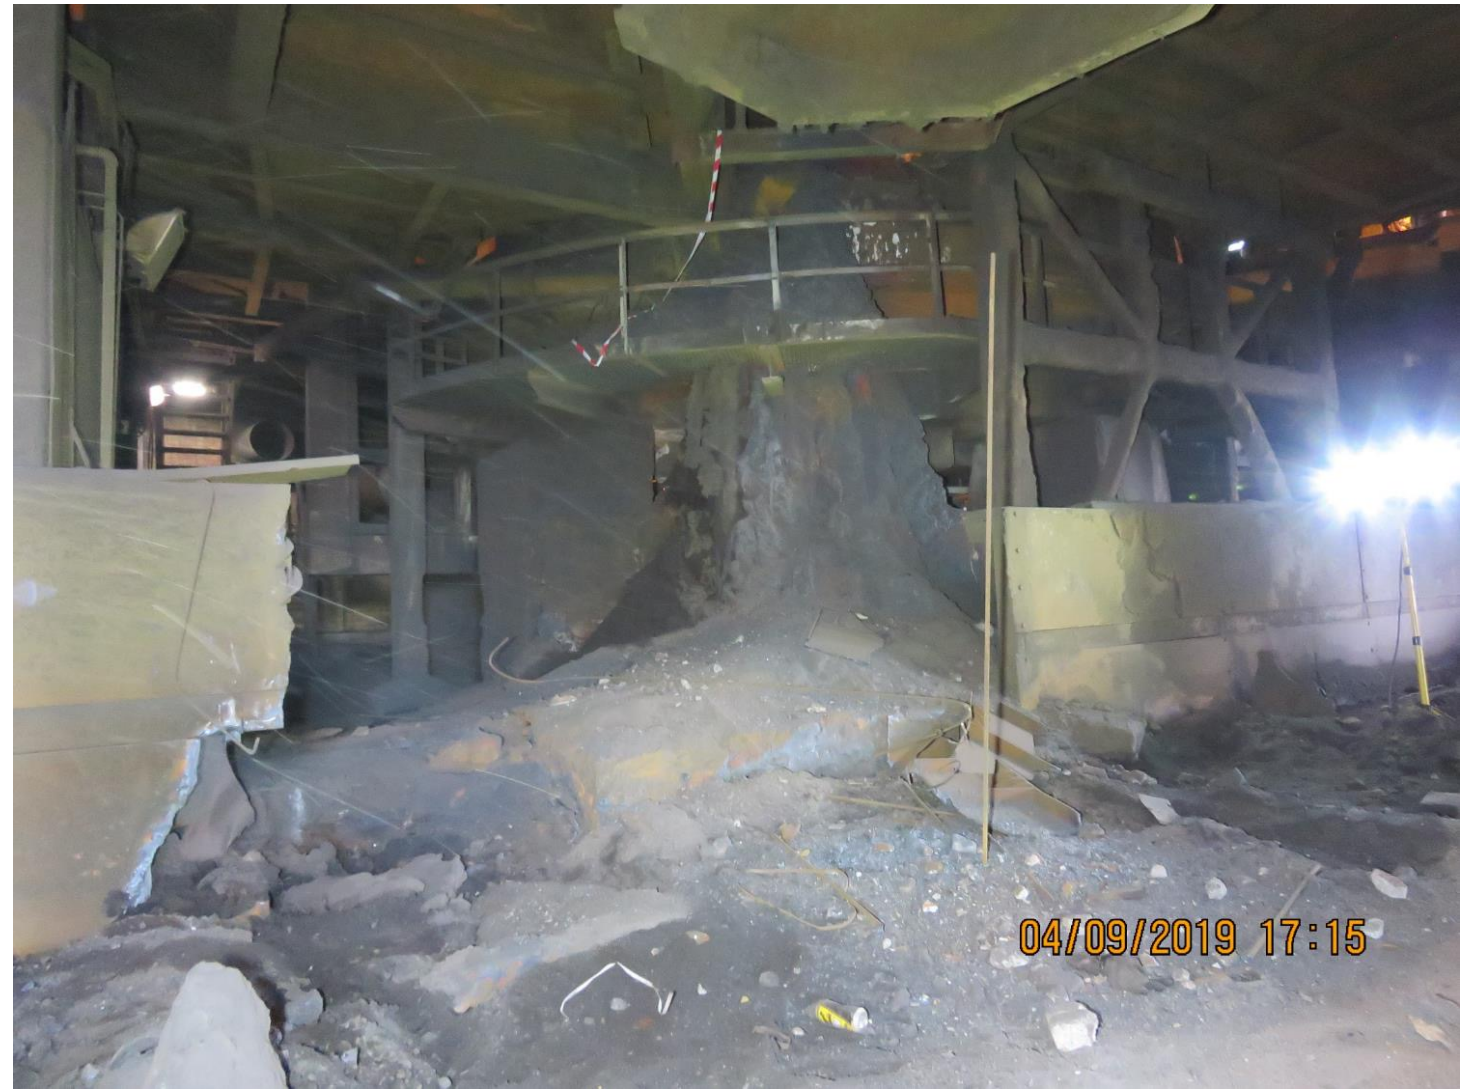
Furnace Losses

- Control = Residual Heat
- Dependency = Cooling/ Isolation Installation
- Verification = Temperature Probes
- Control Quality = Human Behaviour

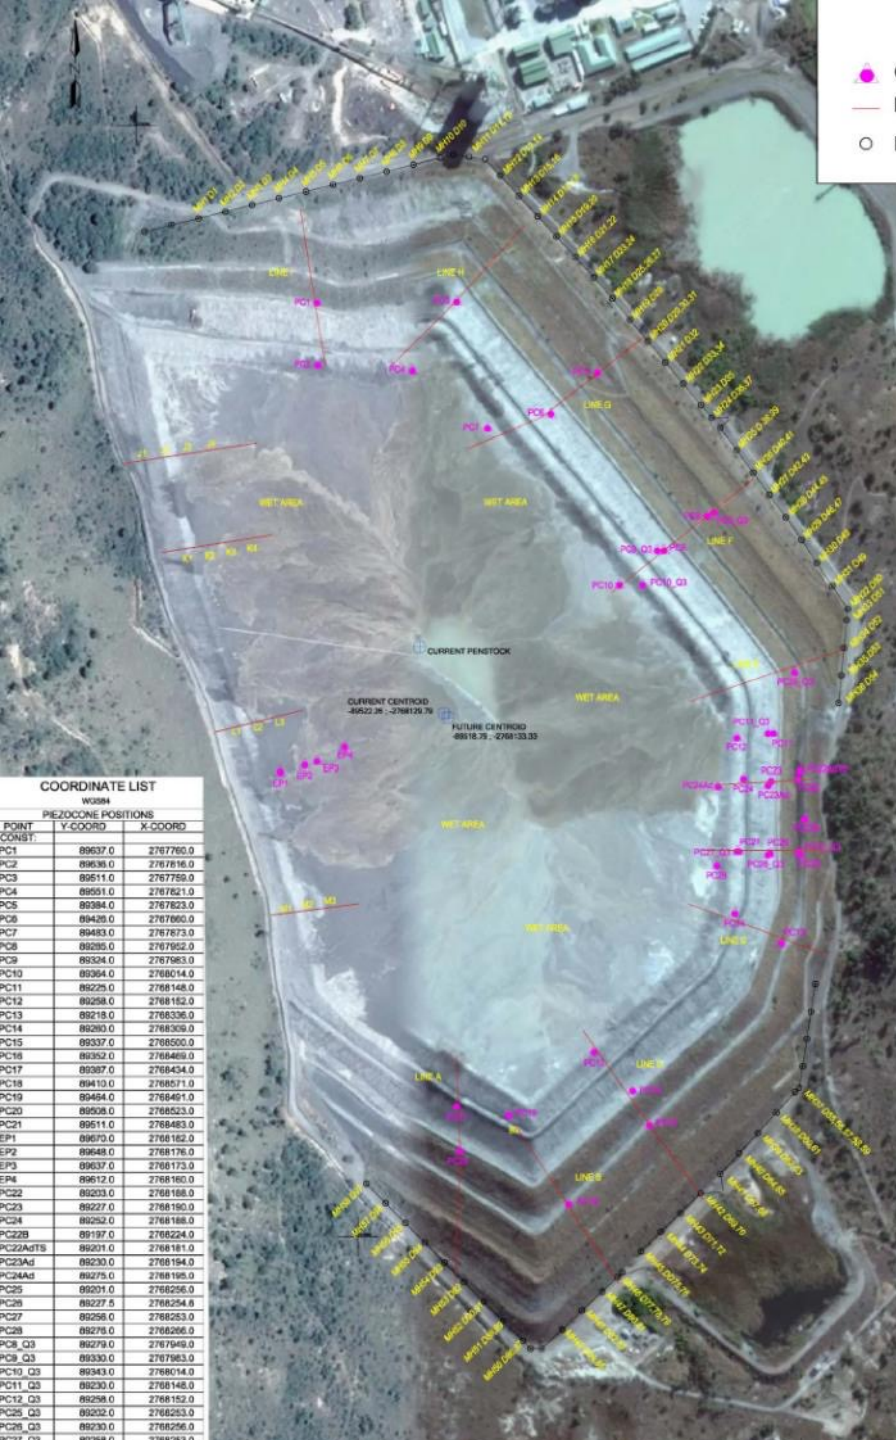
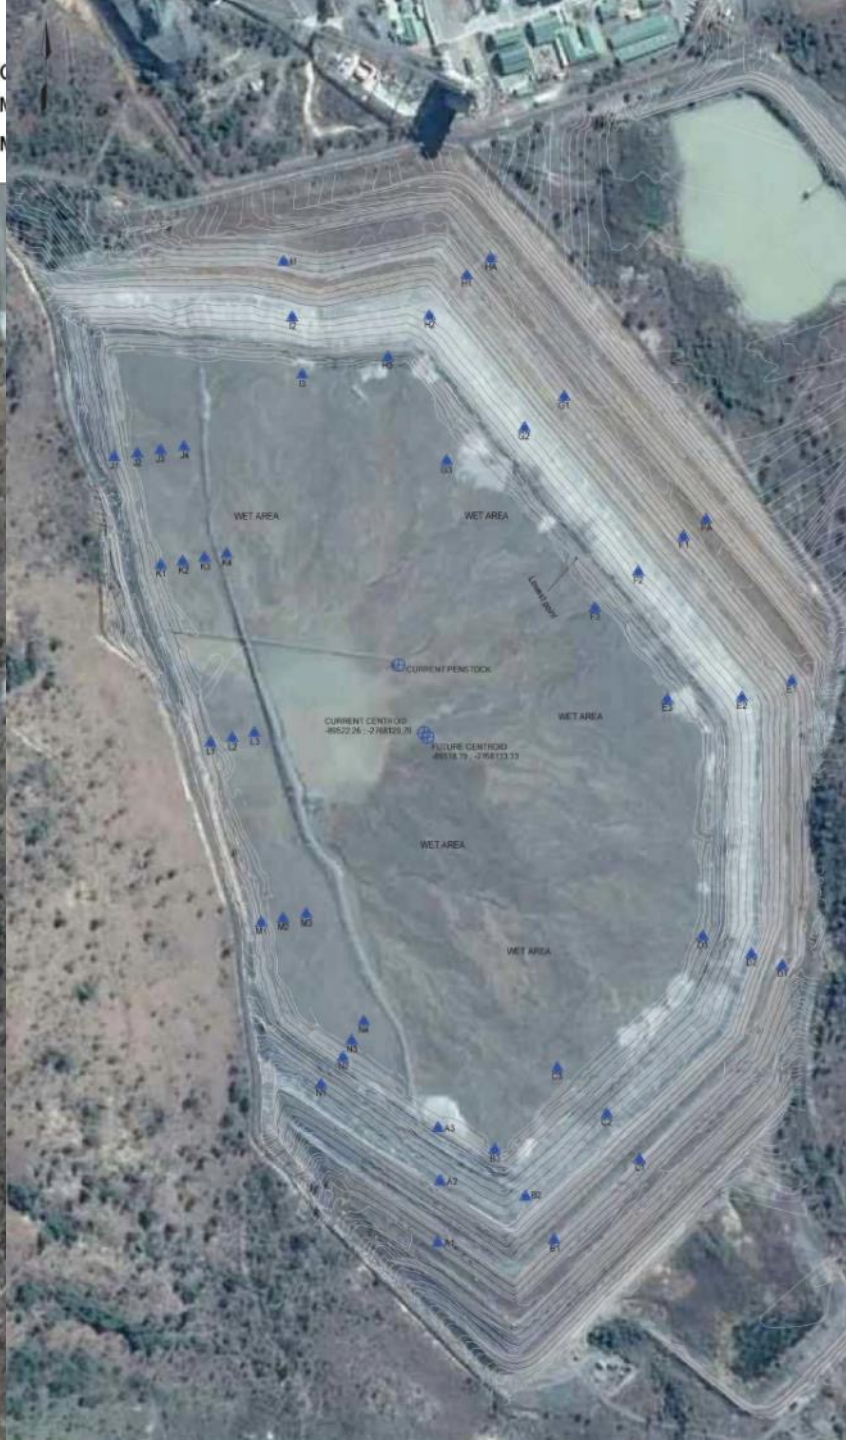
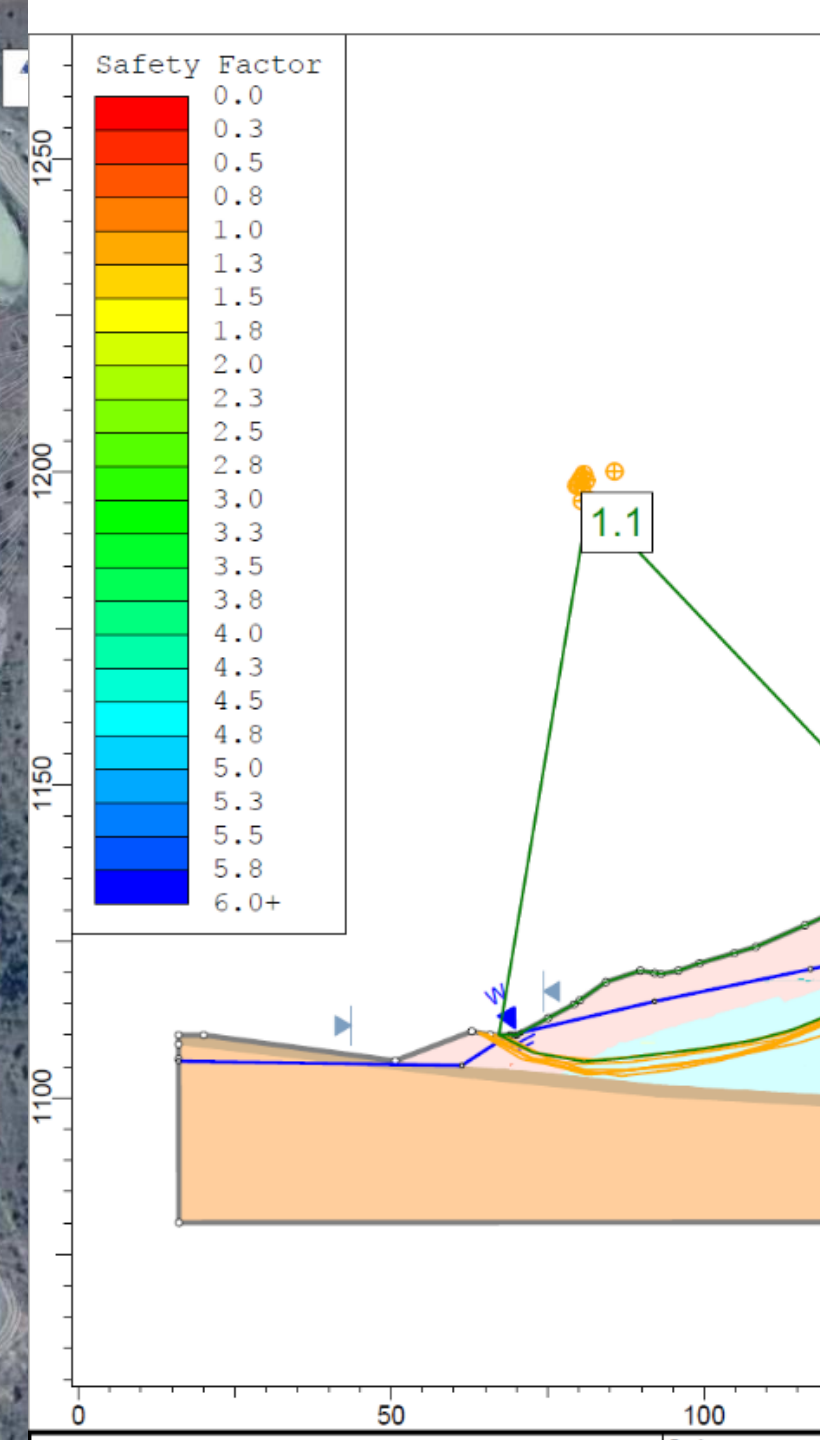
TSF

Section evaluated	"Worst Case" Status Quo	"Best Estimate" Status Quo
Line A	1.3	1.4
Line B	1.3	1.6
Line C	1.3	1.5
Line D	0.9	1.2
Line O	1.1	1.2
Line P	1.0	1.1
Line E	1.1	1.2
Line F	0.8	0.9
Line G	1.1	1.1
Line H	1.2	1.2
Line I	1.1	1.3

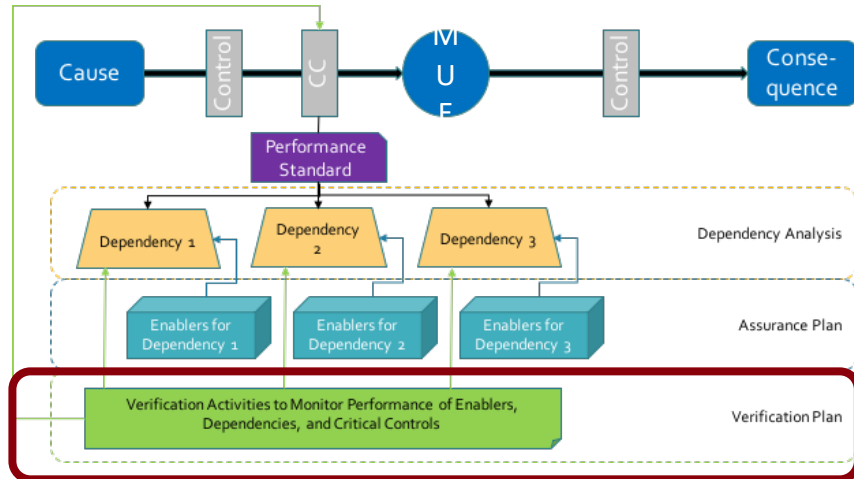
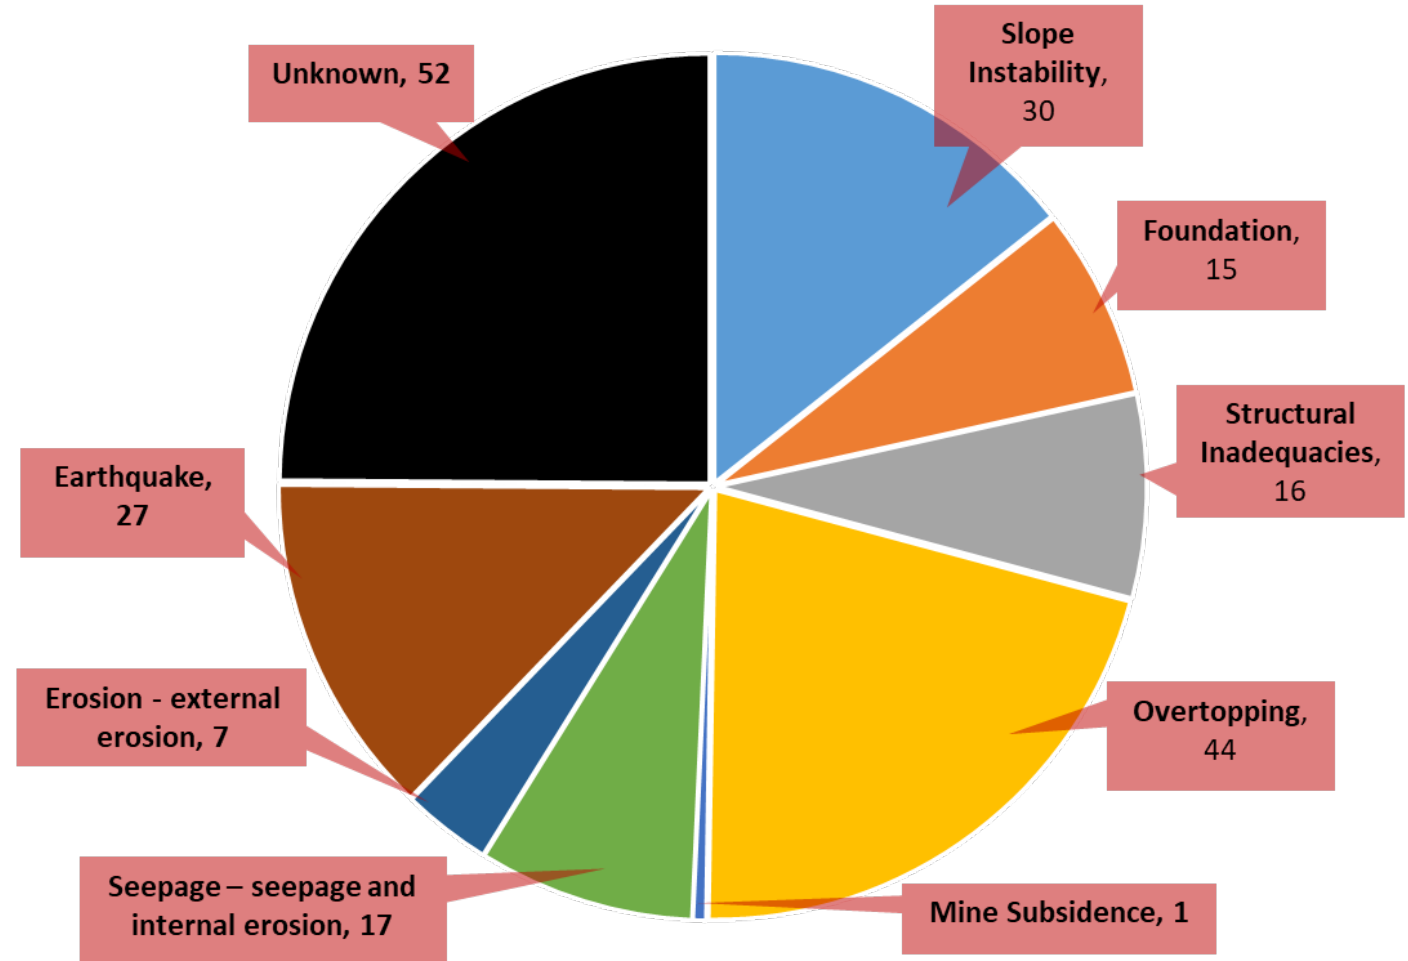
TSF

- Control = Static Liquefaction
- Dependency = Water, Fines
- **Verification = Phreatic Surface**
- Control Quality = Human Behaviour

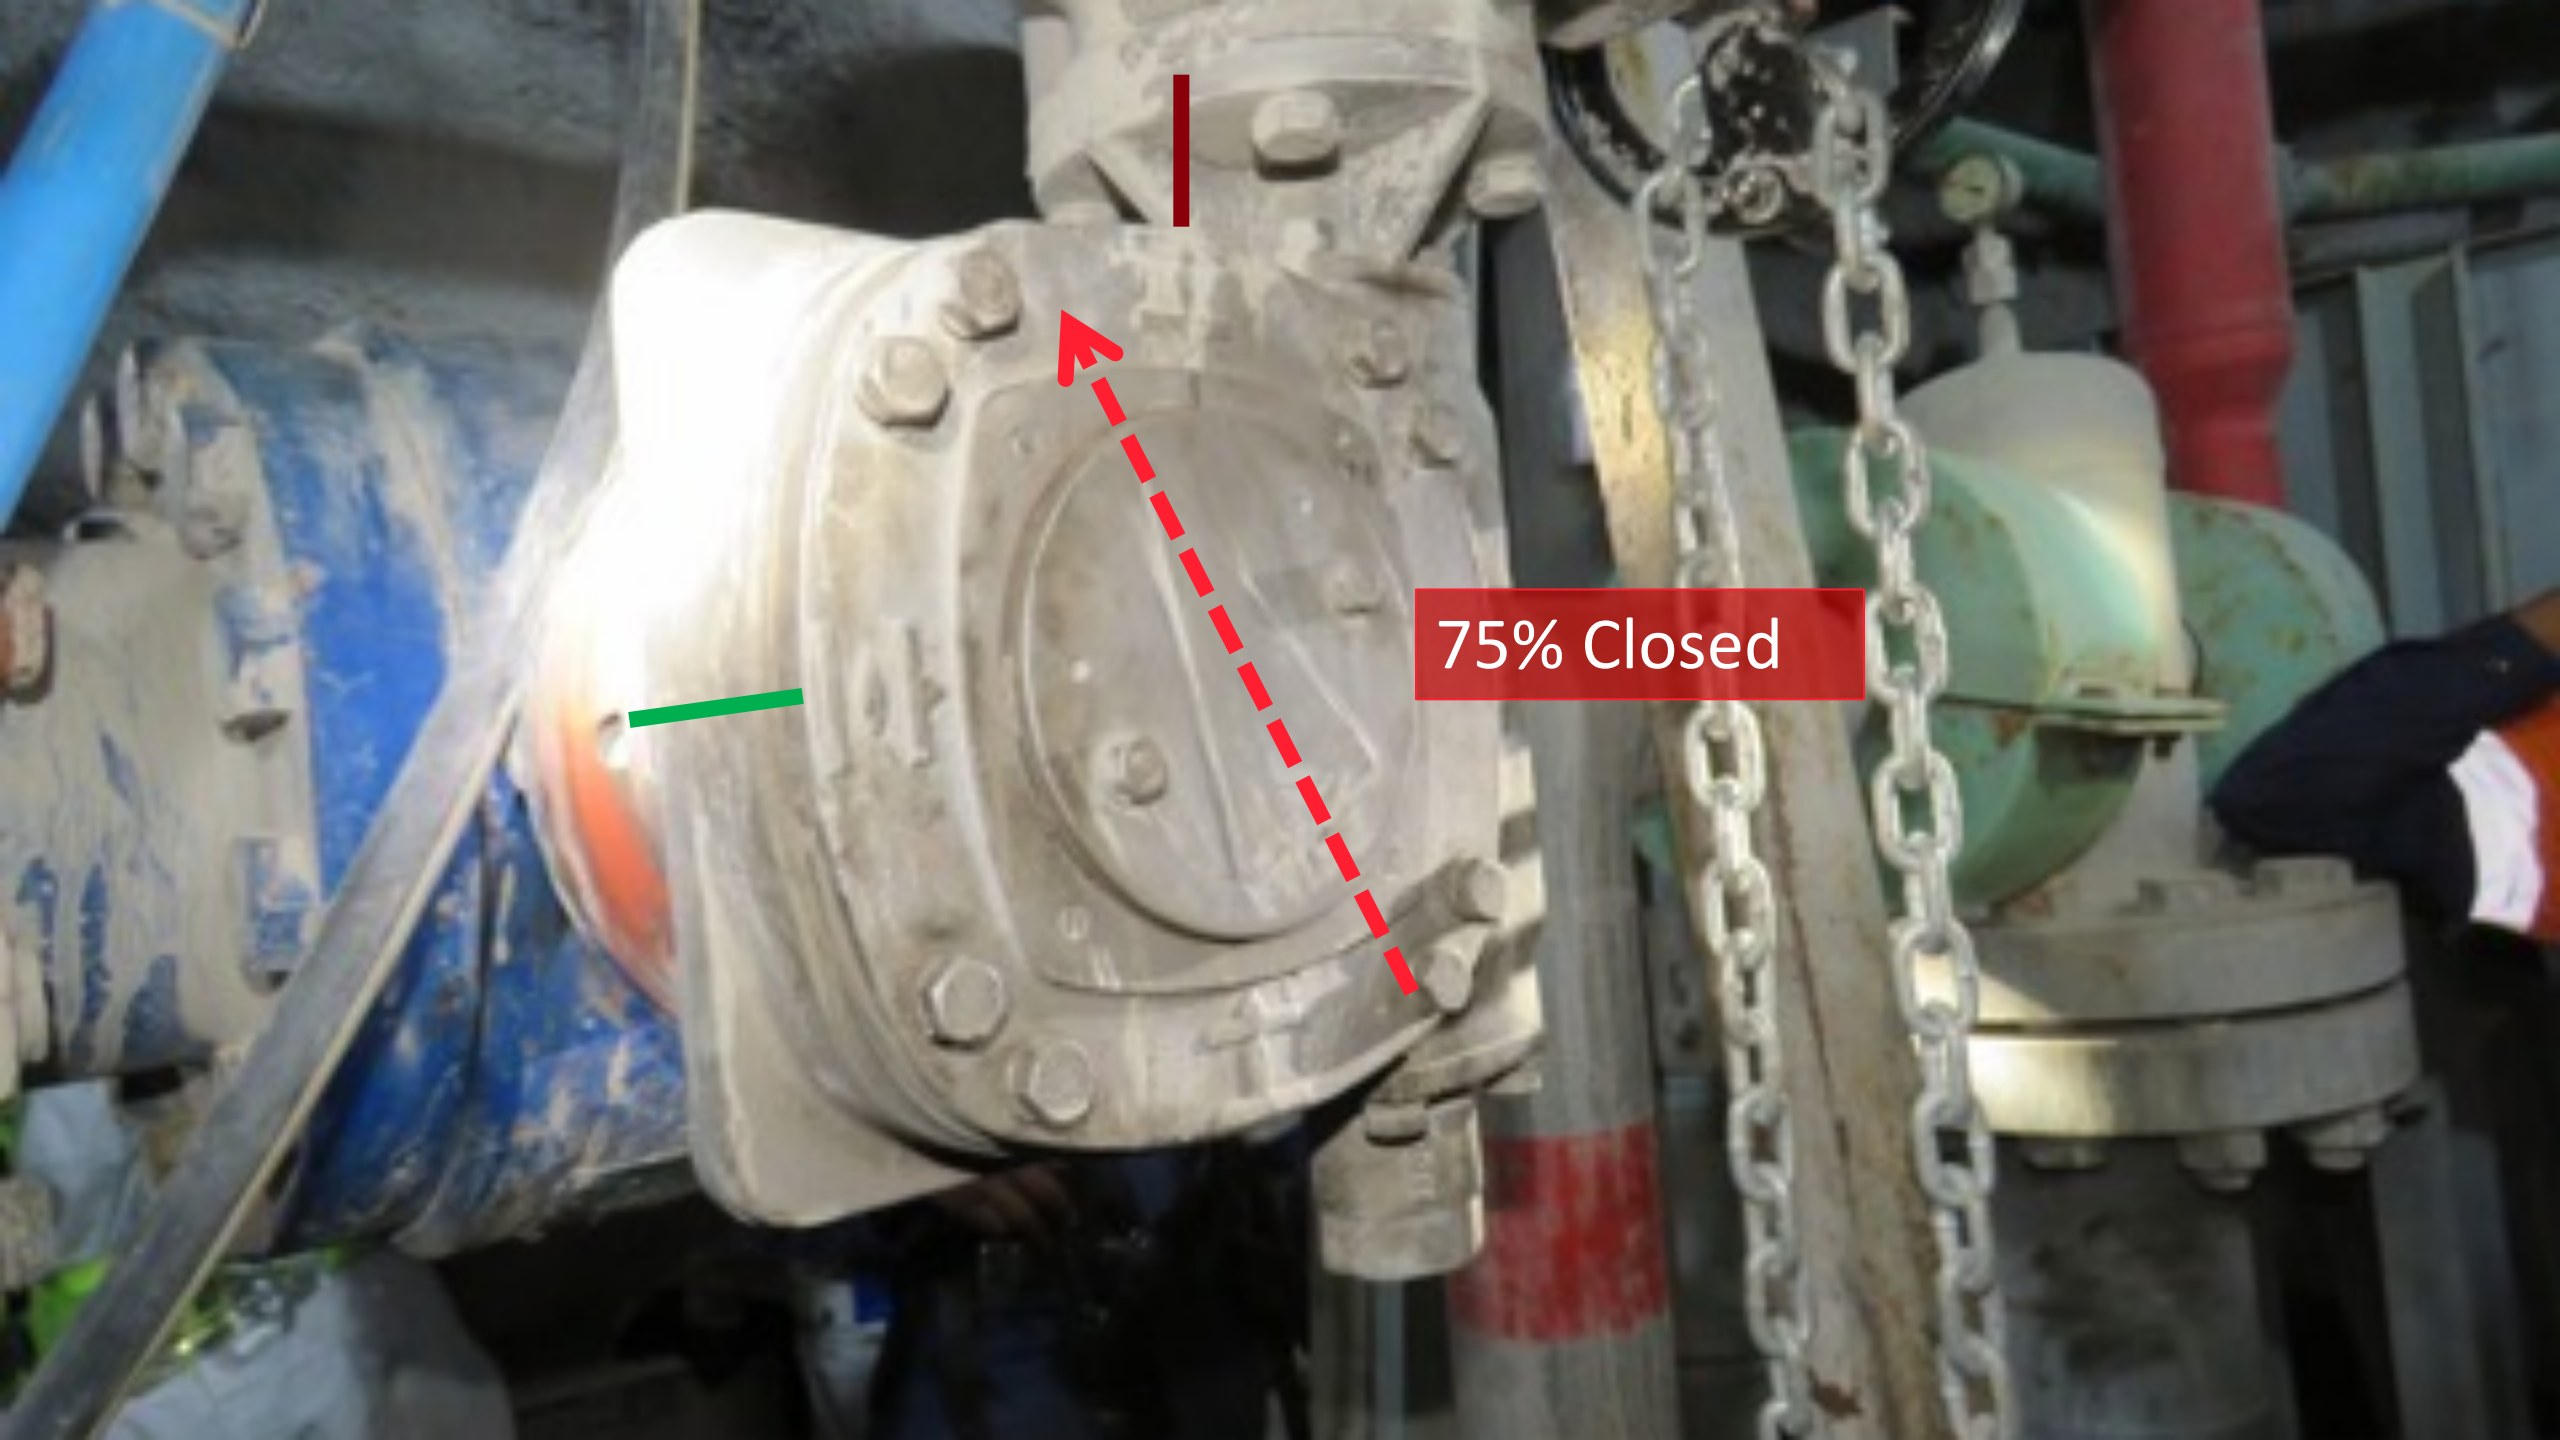
75% Closed

Conveyor Fire

- Inadequate Water Supply

- Incorrect Bottom Roller Support Bracket Fabrication

- Control System Override Function

- Automatic Control Valves not Installed to DCS

- Control Valve Manually Manipulated and Only 25% Opened

Compliance Items Recorded, but
None of The Issues Identified in Risk Survey or
Monitoring Activities
