Major Mining Claims and Risk Control Failures

Le Roux van den Berg
Lloyd Warwick International

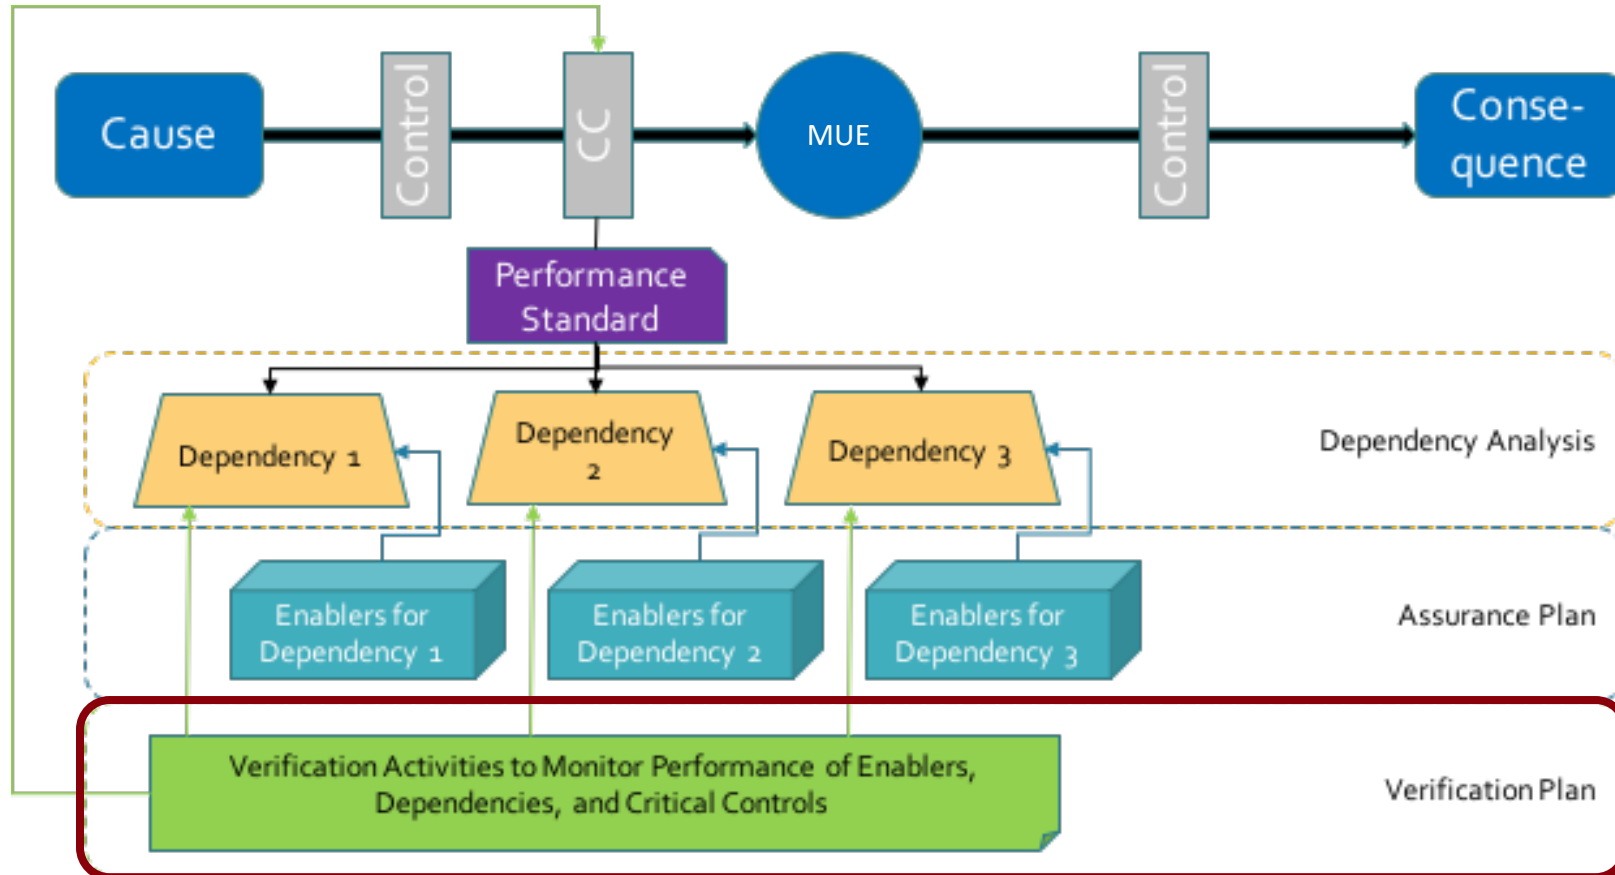
Conveyor Fire

- Control = Fire Suppression
- Dependency = Water pressure, Water flow, Accurate detection
- Verification = Pressure Gauge, Flow Valve Position, Detection Testing
- Control Quality = Human Behaviour
