Major Mining Claims and Risk Control Failures

Le Roux van den Berg
Lloyd Warwick International

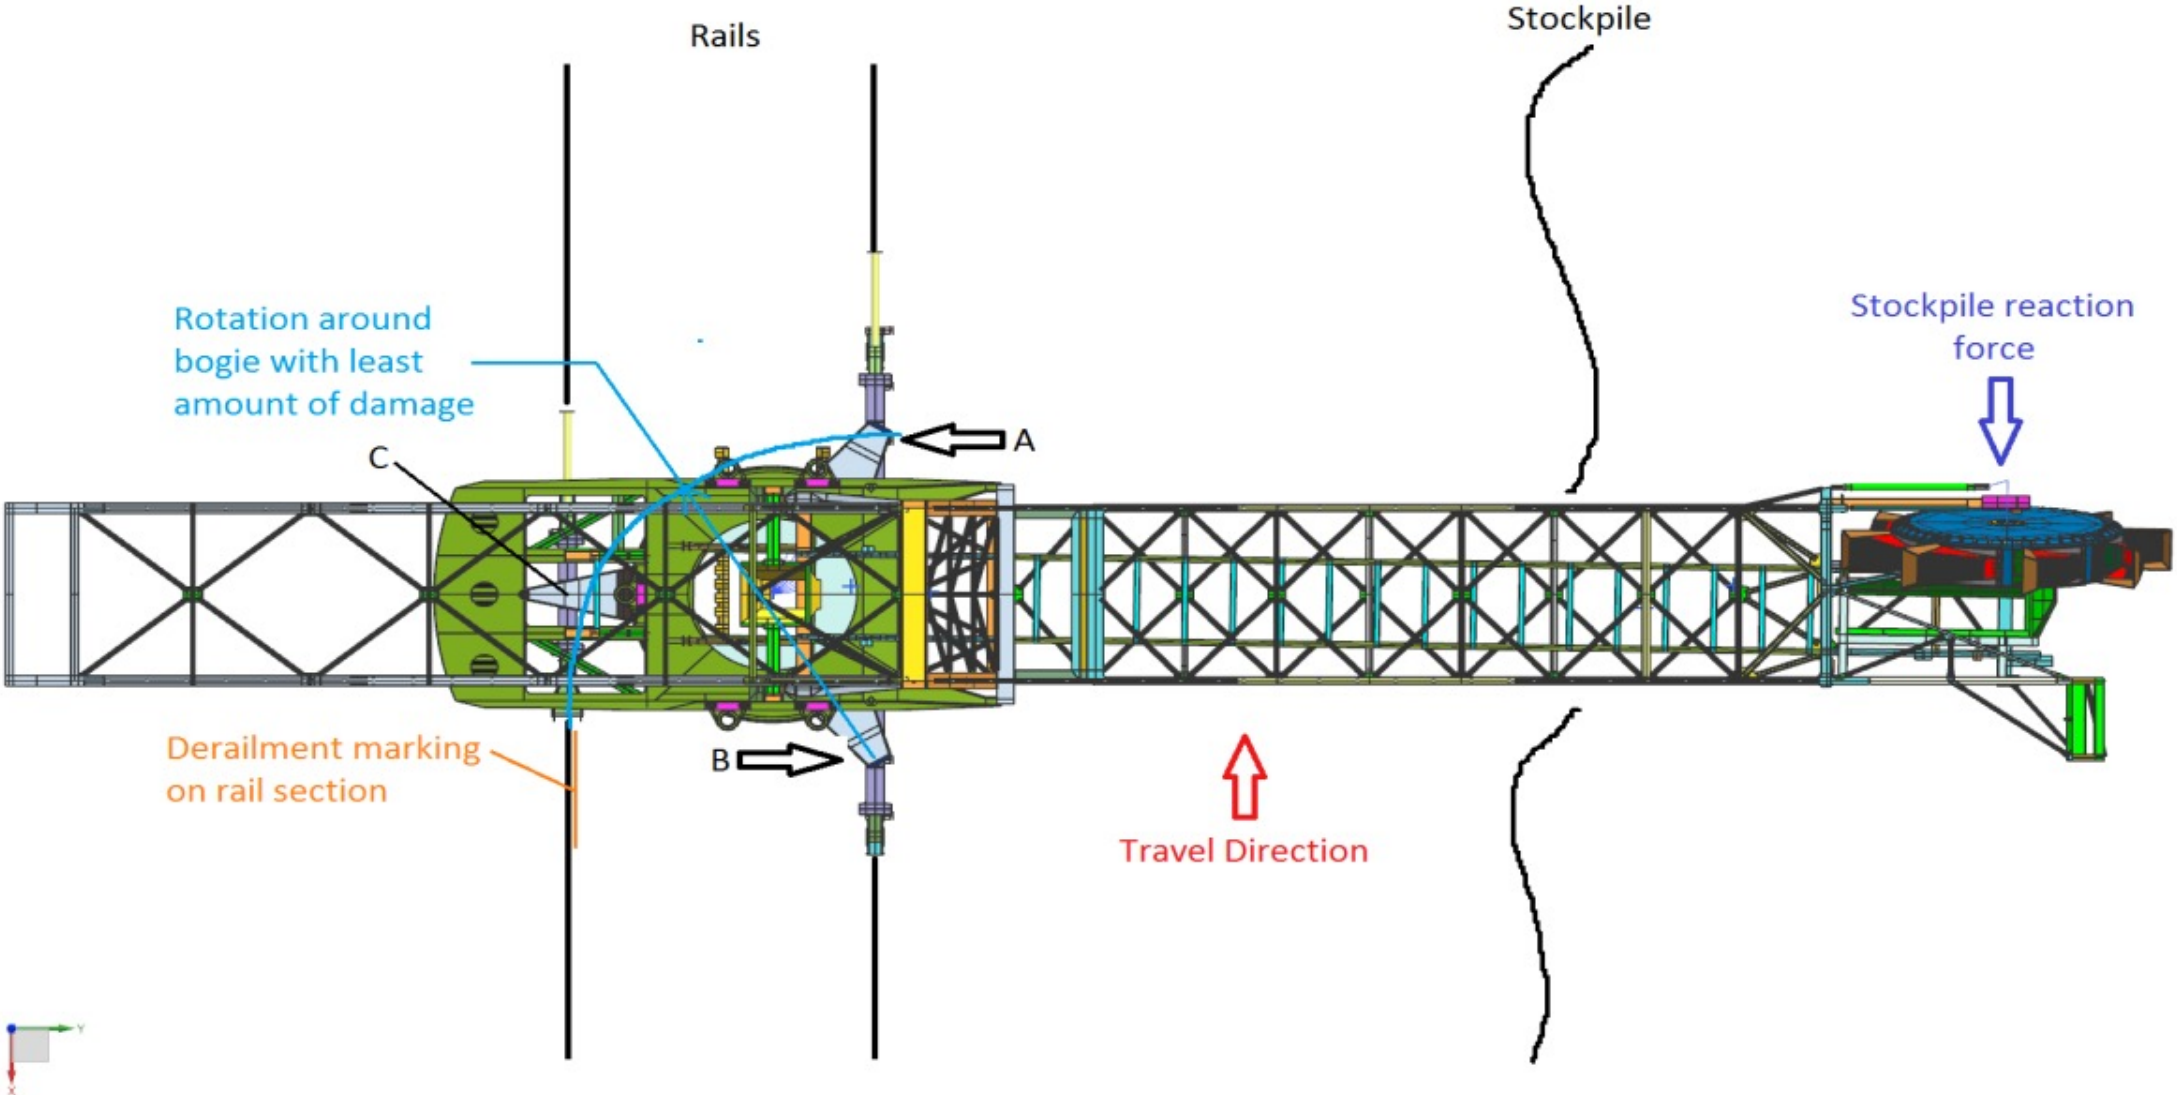
Equipment Collapse

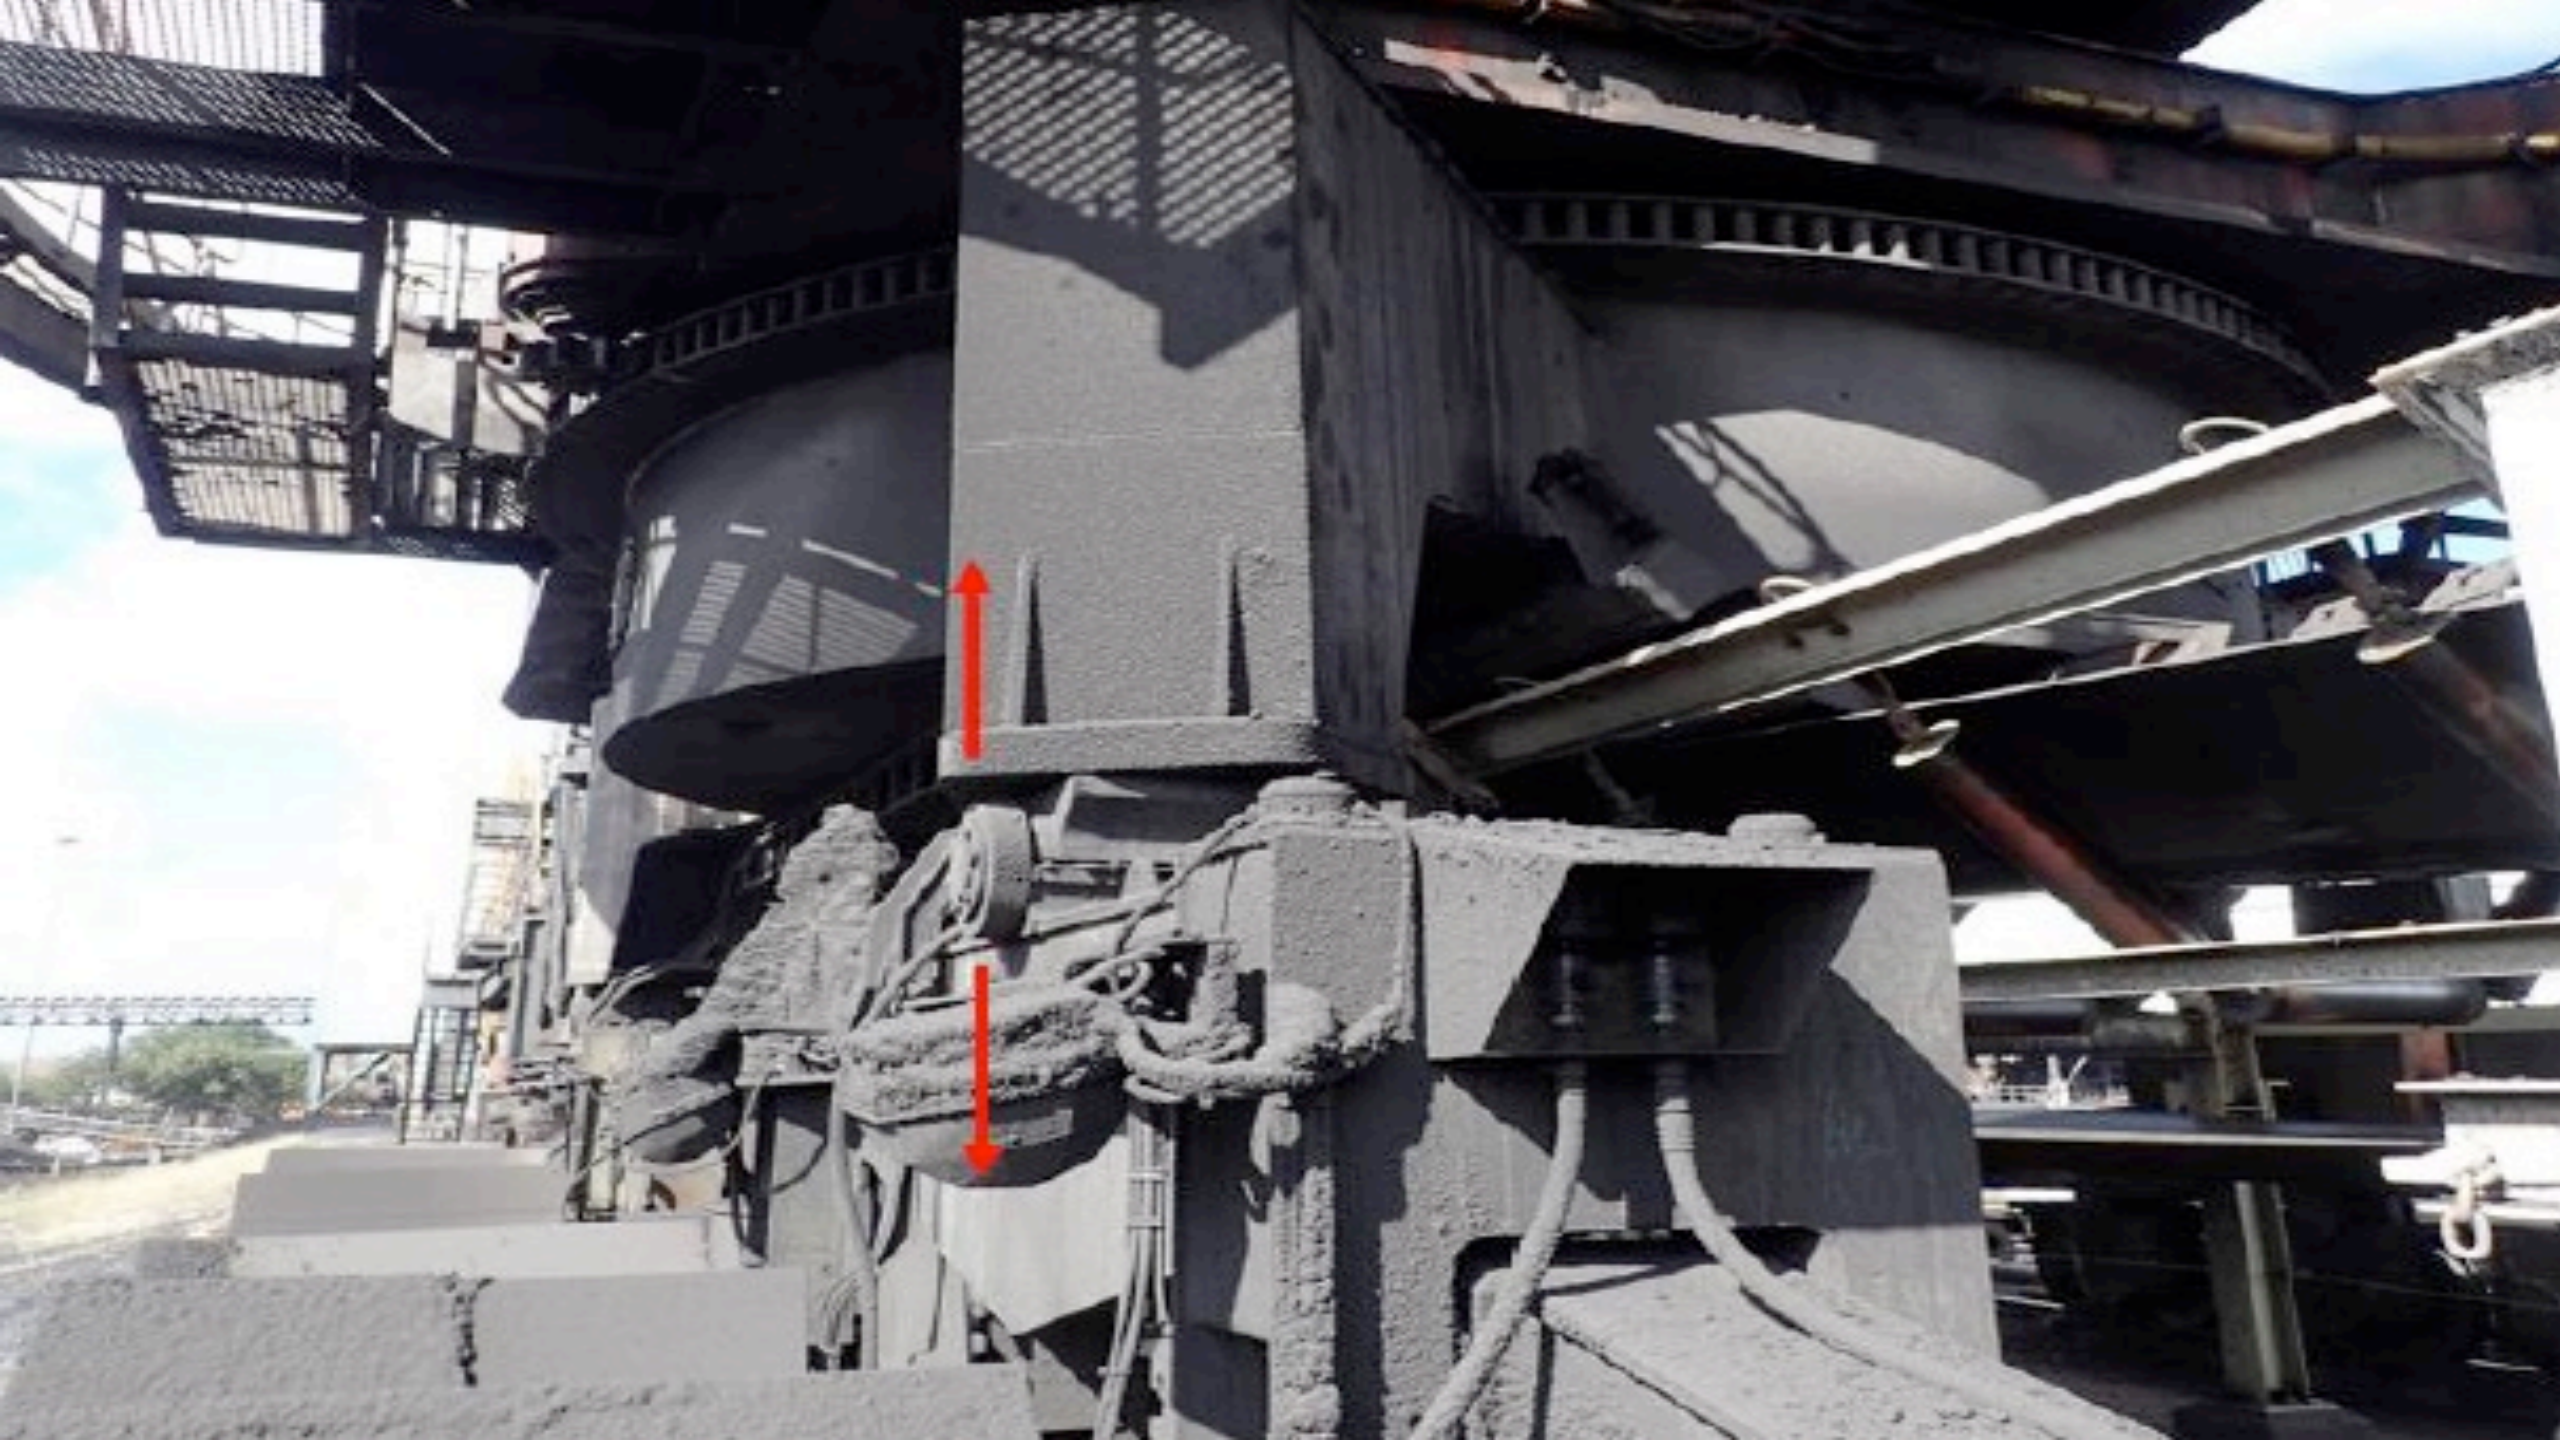
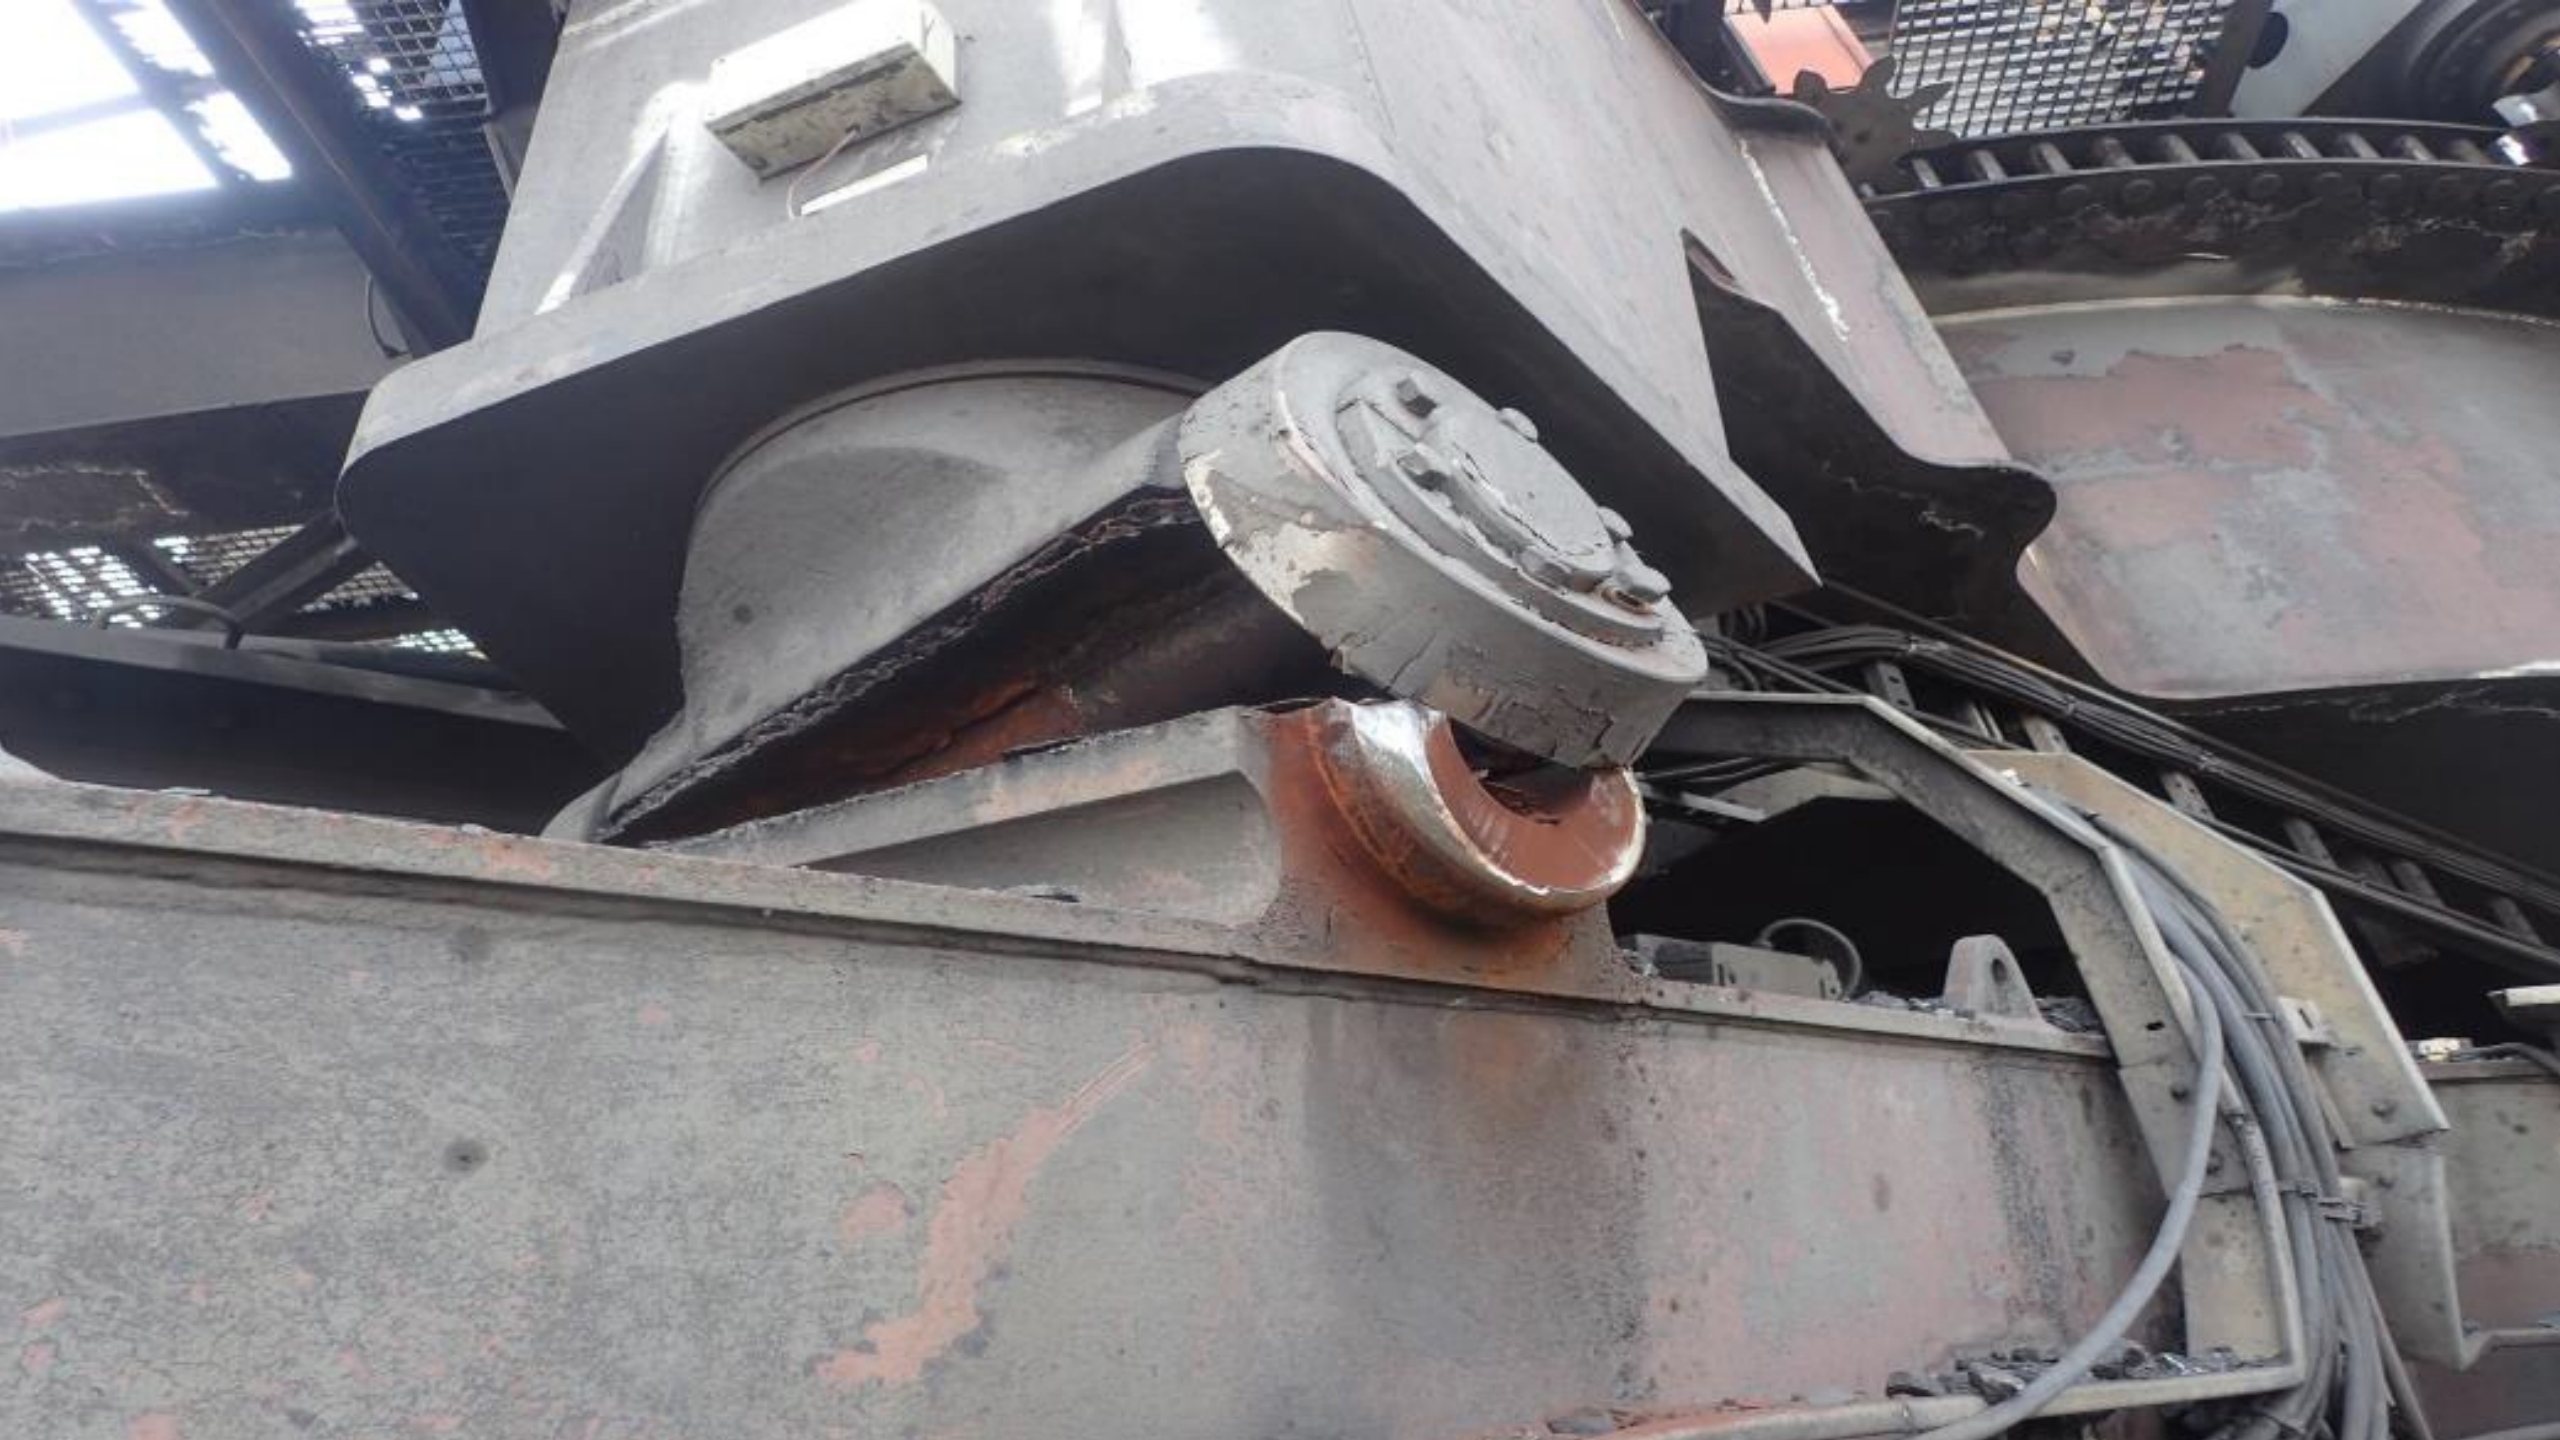
Equipment Collapse

- Control = Reclaimer height when staking
- Dependency = SOP, Equipment Integrity
- Verification = None
- Control Quality = Human Behaviour; Engineering

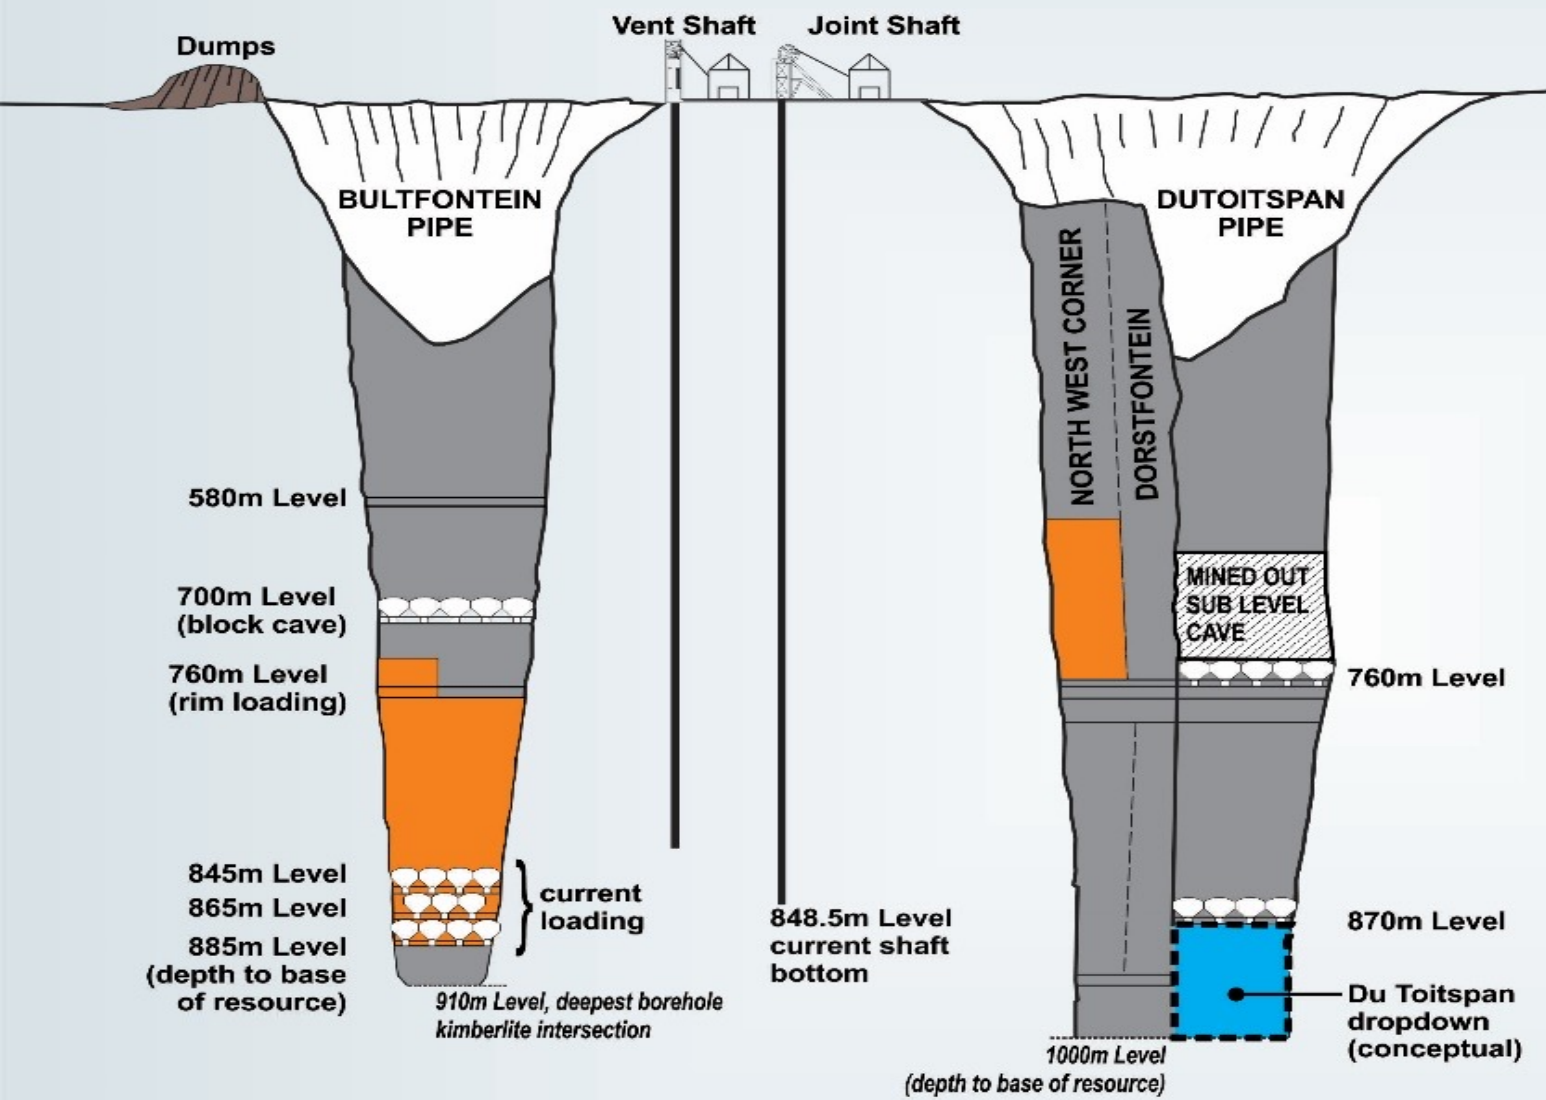
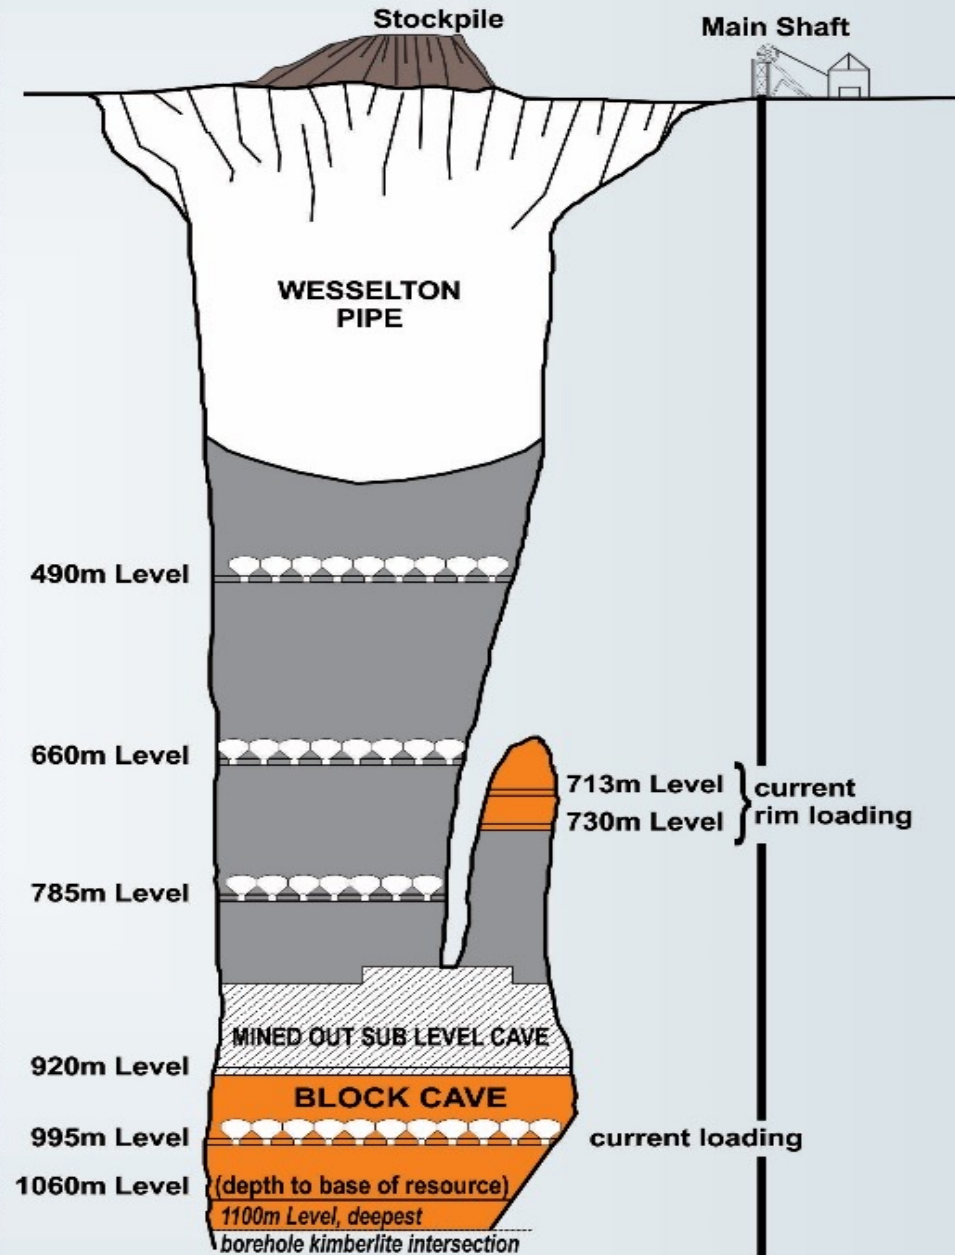
Mud Rush

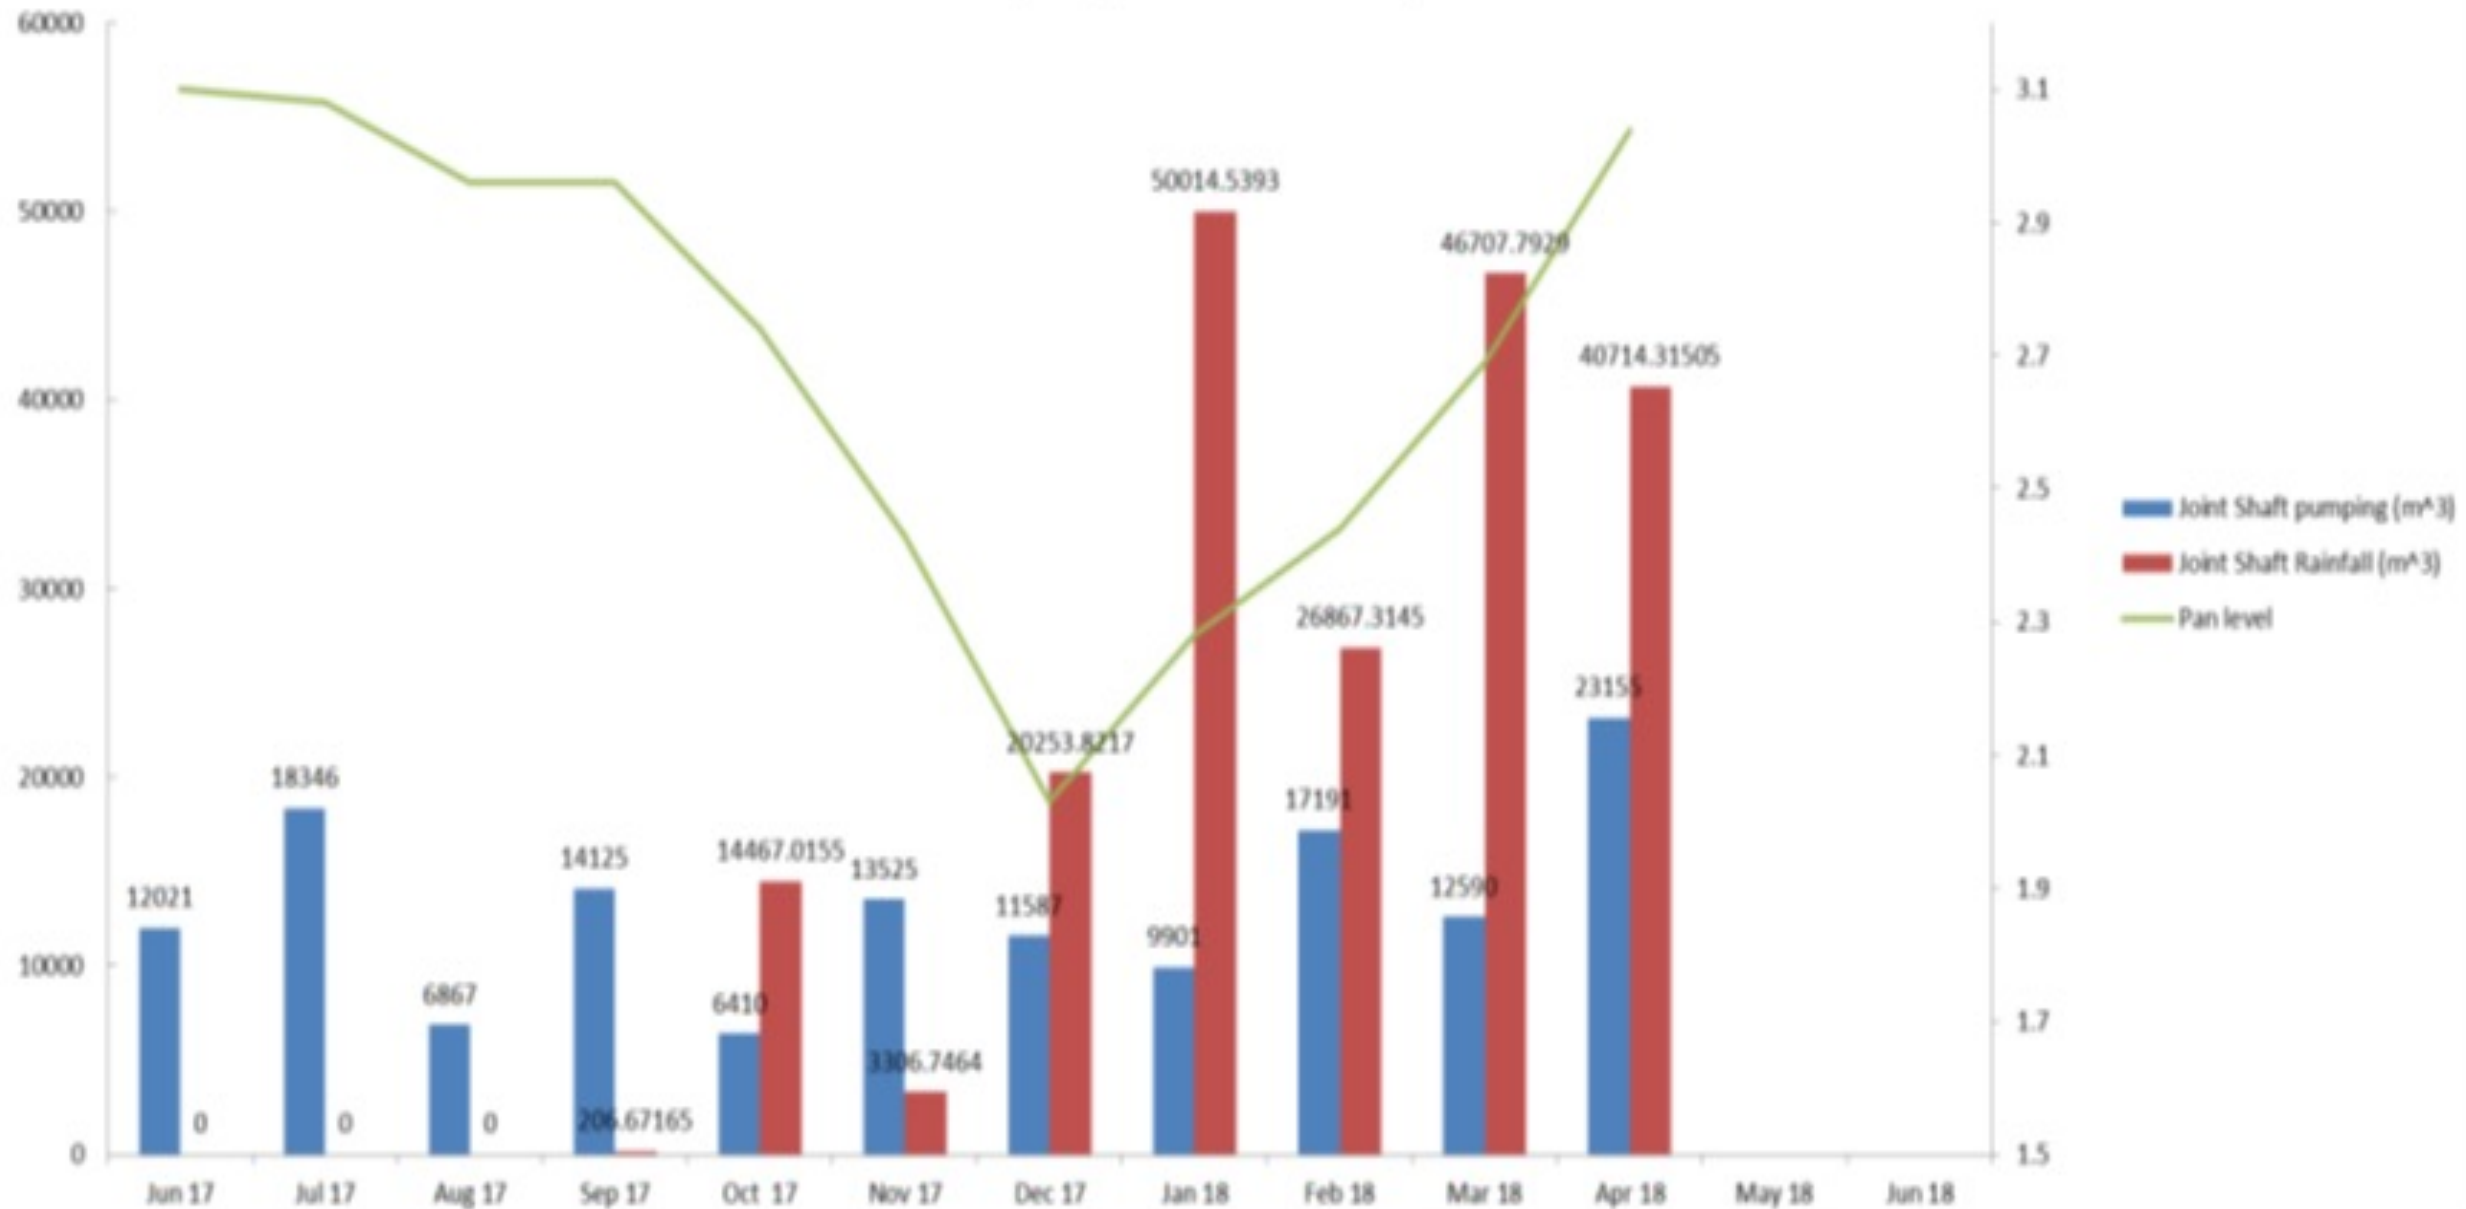
Joint Shaft Pumping, Rainfall and pan level 2017 - 2018

Mud Rush Requirements:

1. Fines
(mud forming material)
2. Water
(sufficient to wet fines)
3. Trigger
(disturbance to initiate movement)
4. Discharge Point
(to allow material to enter workings)

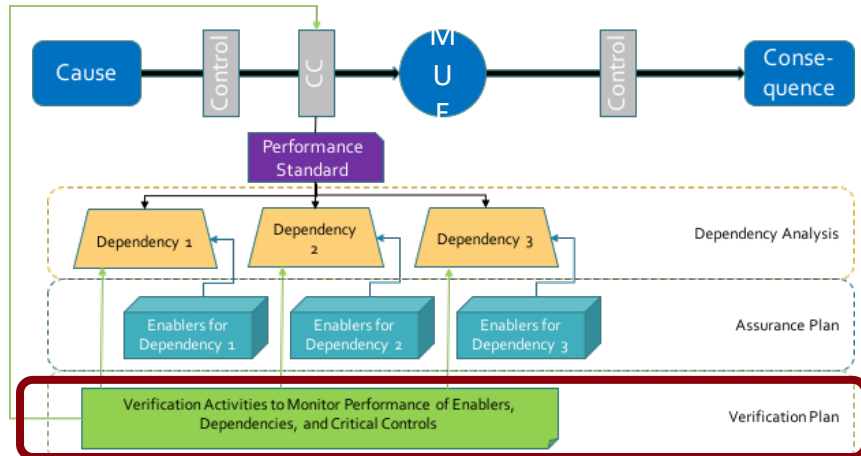
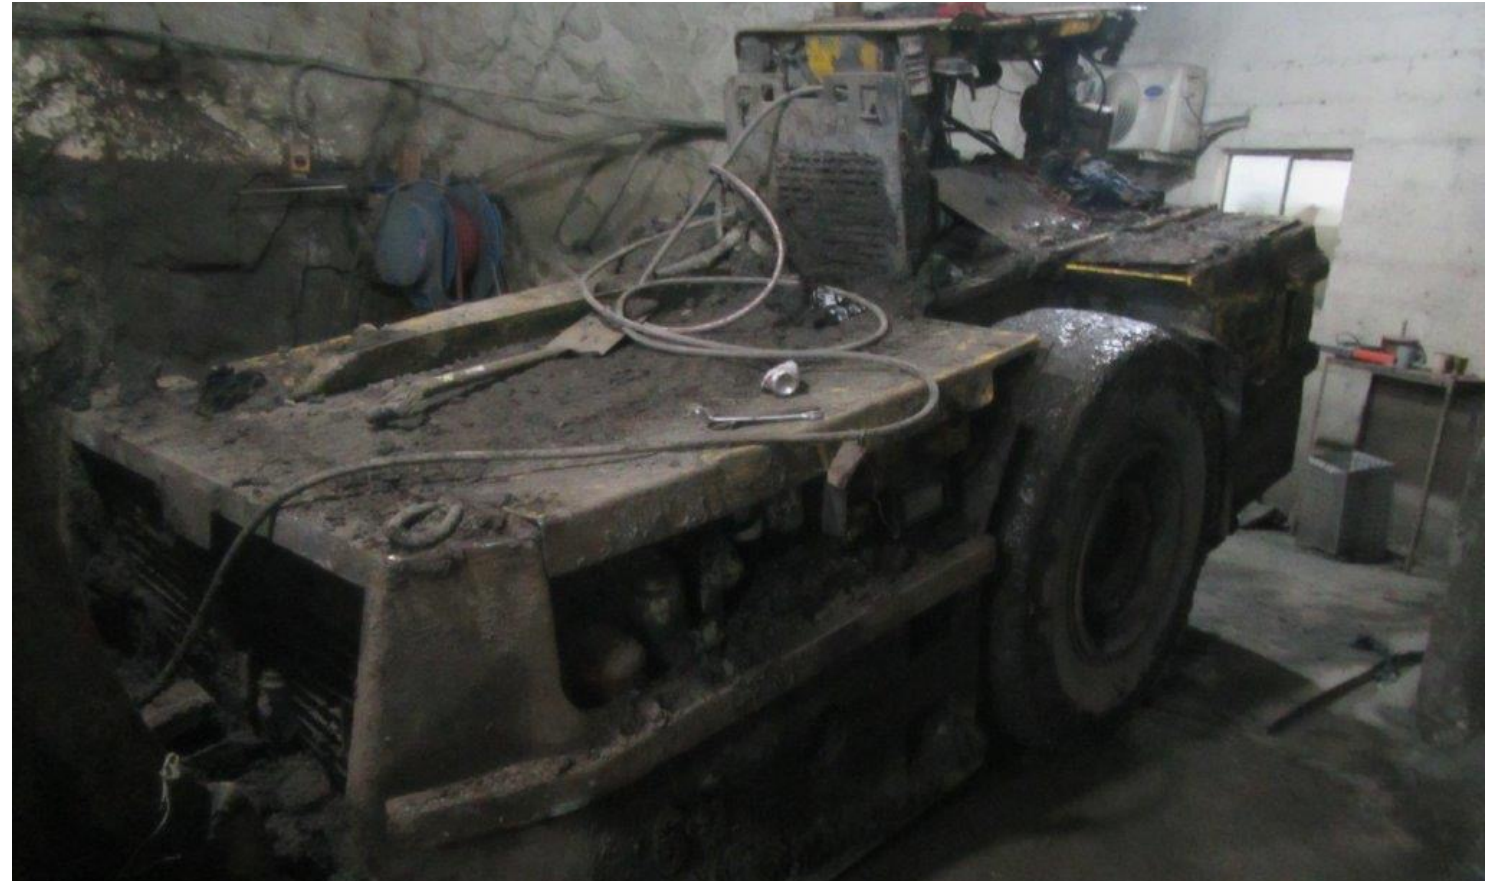
Mud Rush

- Control = Water level
- Dependency = Pumping
- **Verification = Water Balance**
- Control Quality = Human Behaviour

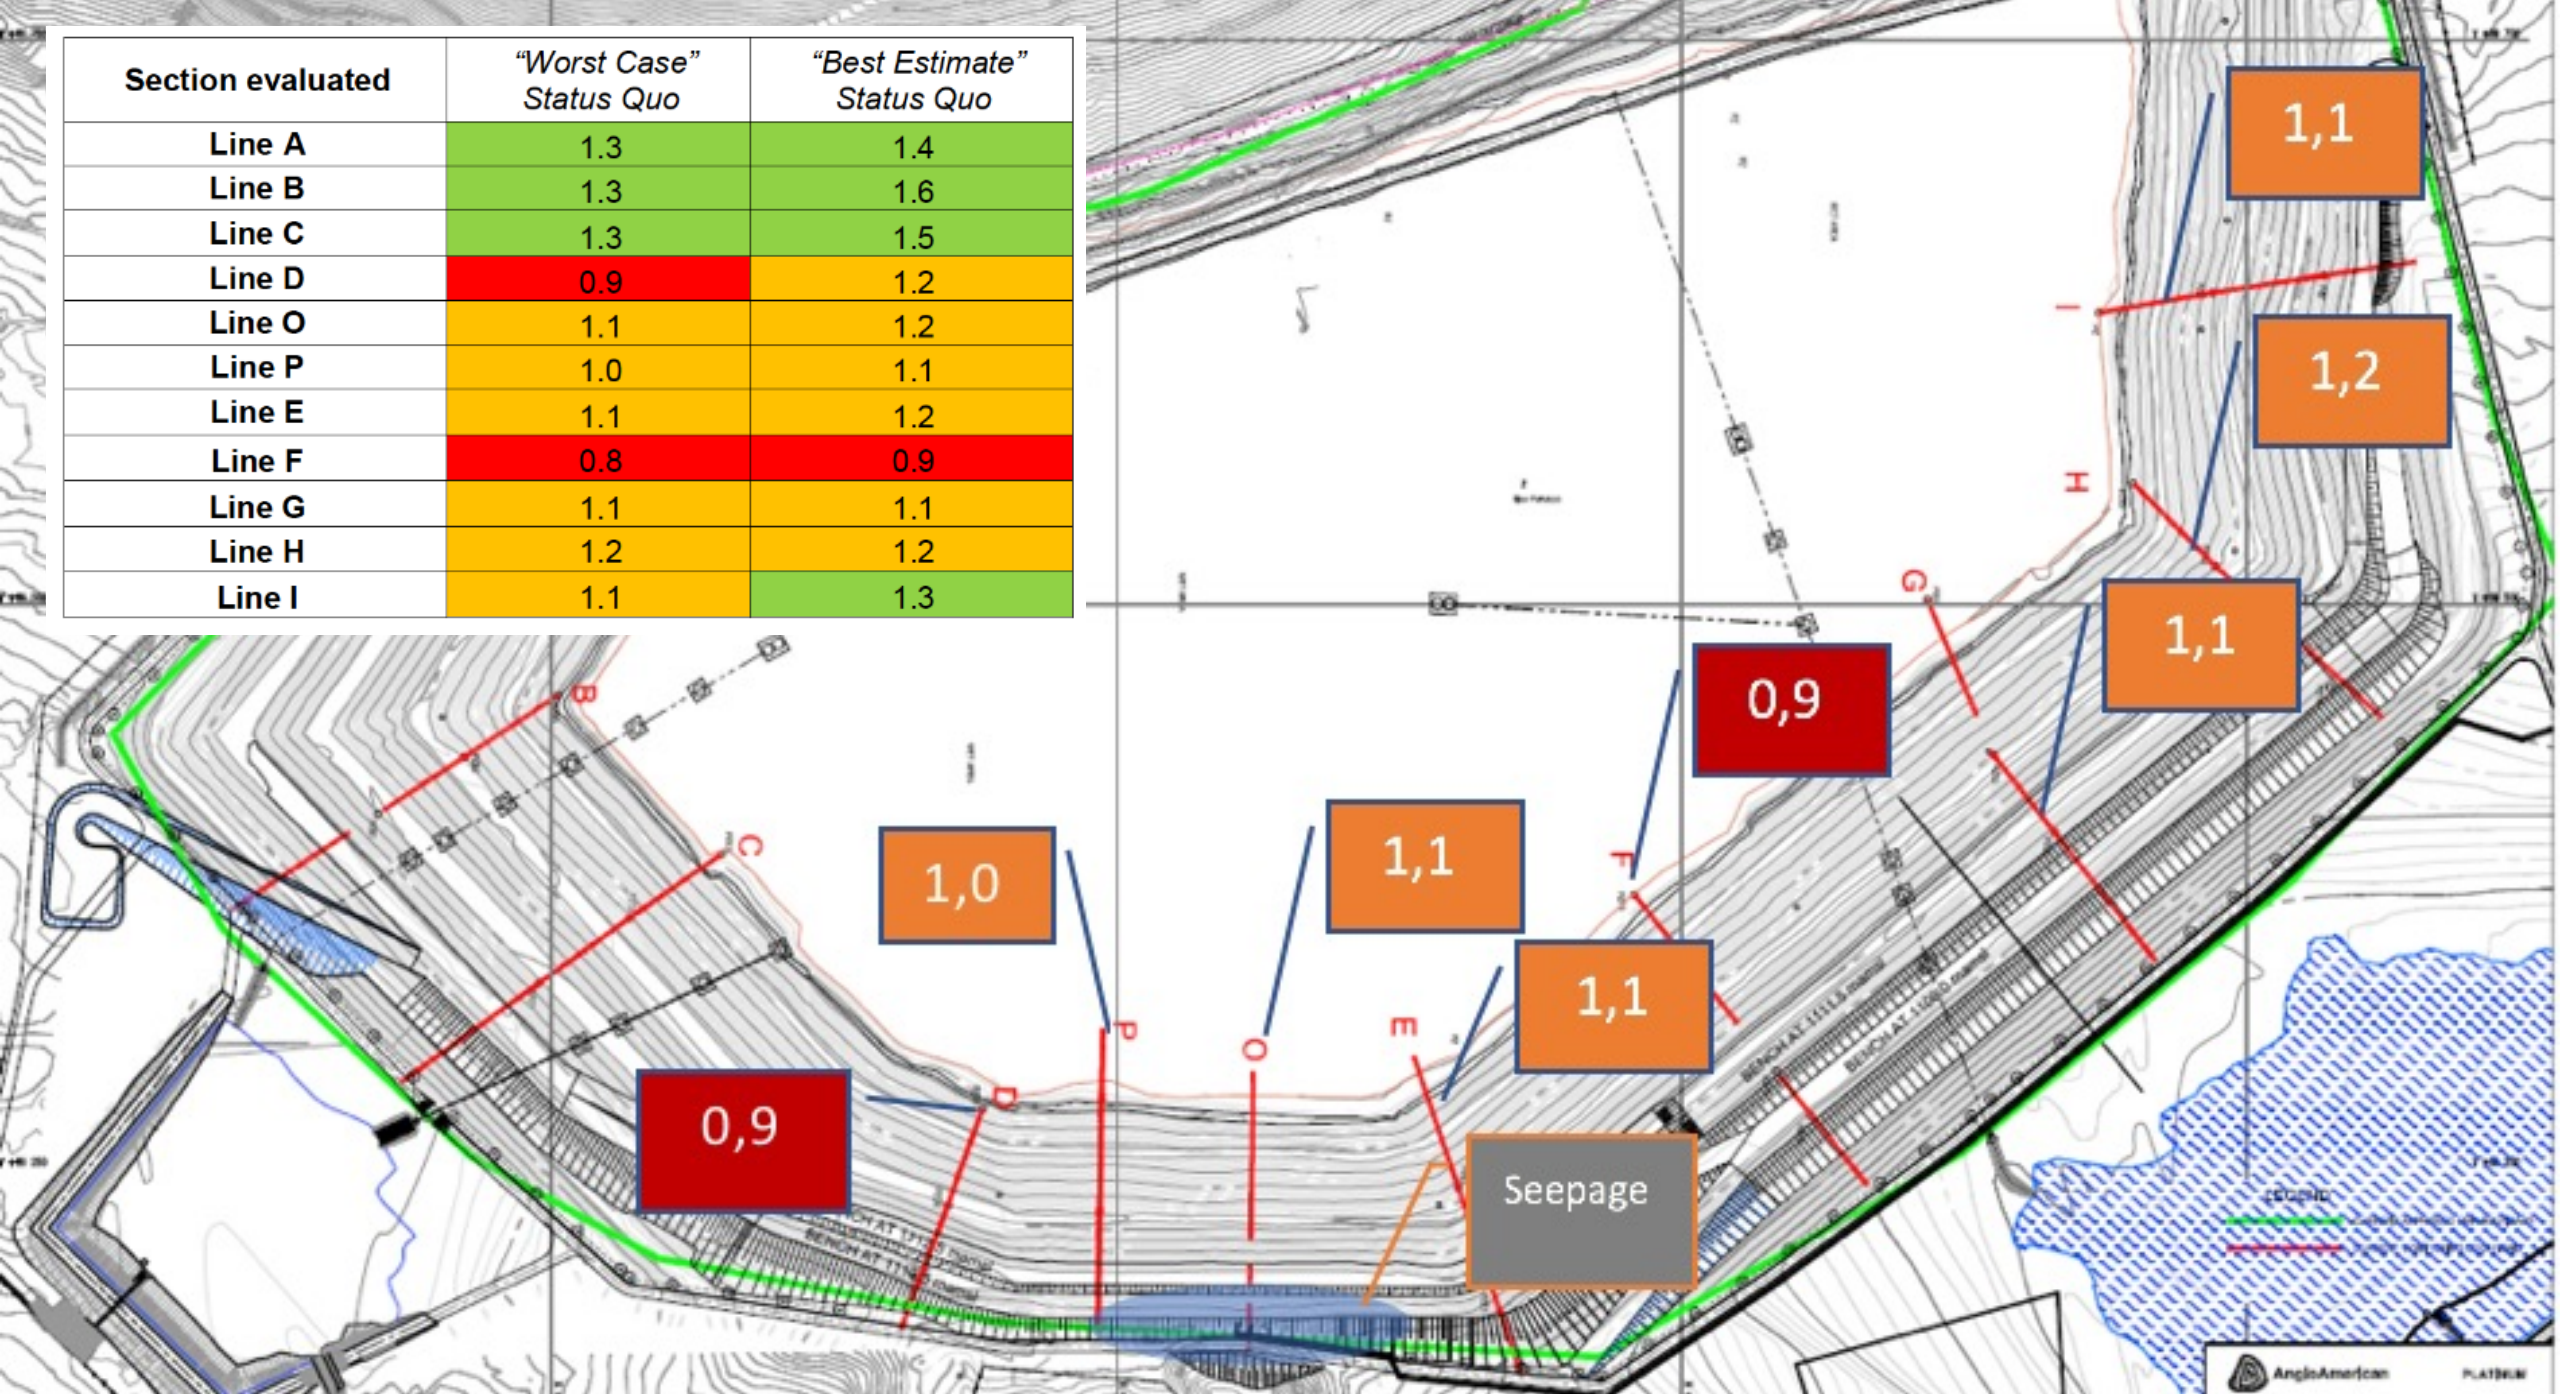
Section evaluated	"Worst Case" Status Quo	"Best Estimate" Status Quo
Line A	1.3	1.4
Line B	1.3	1.6
Line C	1.3	1.5
Line D	0.9	1.2
Line O	1.1	1.2
Line P	1.0	1.1
Line E	1.1	1.2
Line F	0.8	0.9
Line G	1.1	1.1
Line H	1.2	1.2
Line I	1.1	1.3
